Inspection Report

Pre-Sheetrock Sample Report

Property Address:
Sample
Missouri City TX 77459

PROPERTY INSPECTION REPORT

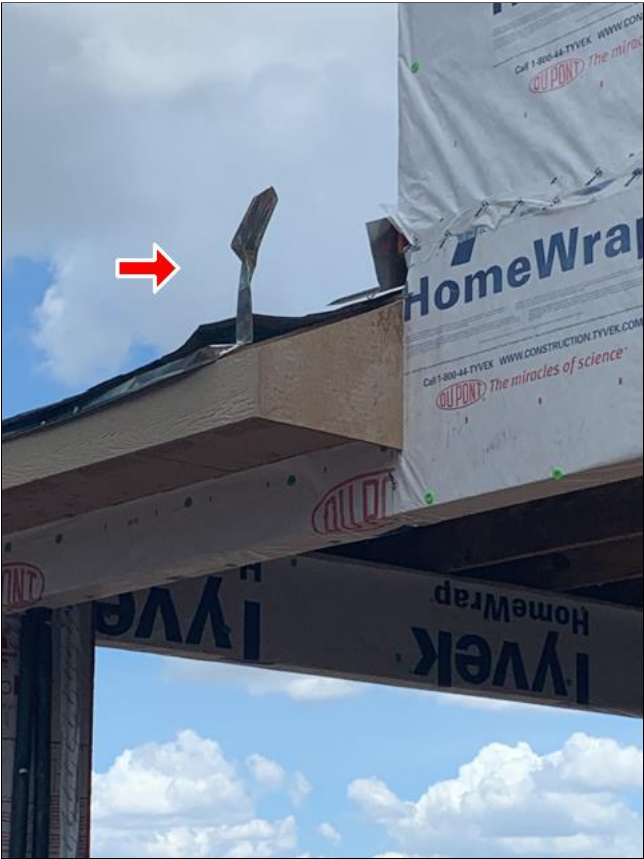
C. Item 1(Picture)

(2) Drip edge flashing is damaged at the rear porch corner

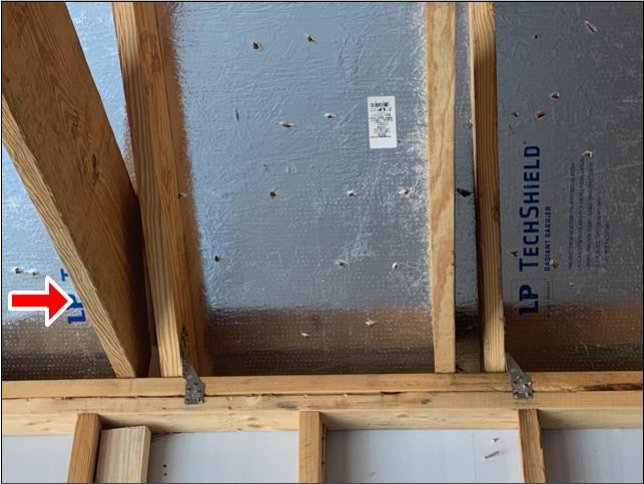
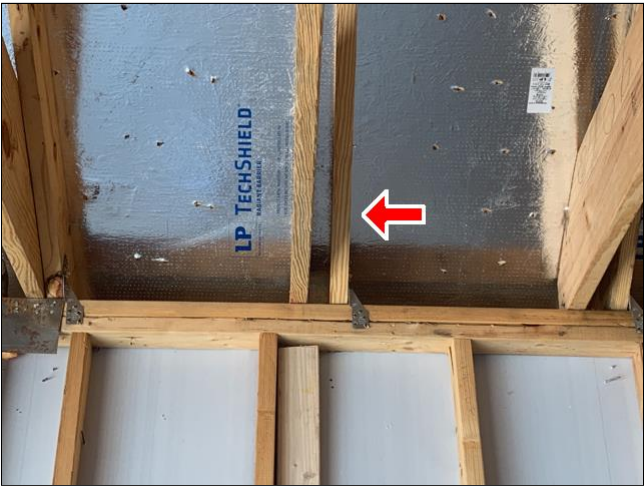
- (1) *The interior and exterior wall surfaces of the home were visually inspected from ground level. Interior walls were checked for sheet rock damage, cracking and signs of water penetration. Minor cosmetic flaws and deficiencies are not normally noted. Exterior walls were inspected for deteriorated wood, brick cracks, warping, levelness, proper flashing, caulking and proper installation of materials. Again, cosmetic deficiencies are not normally noted. The type of exterior wall material is listed below.*
- (2) Three ceiling joists are Not nailed to rafters at the garage west wall

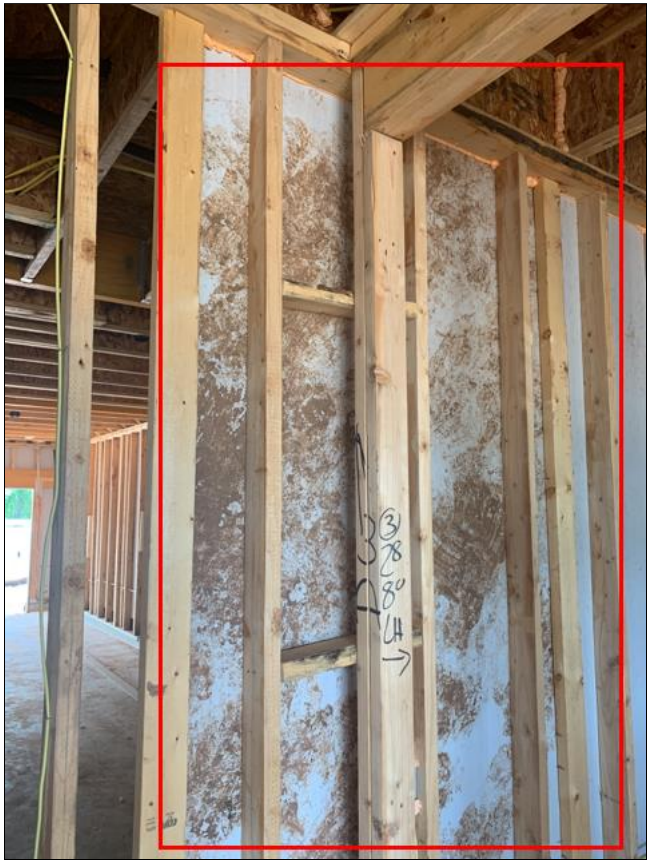
E. Item 3(Picture)

- (3) Clean sheathing of mud throughout house

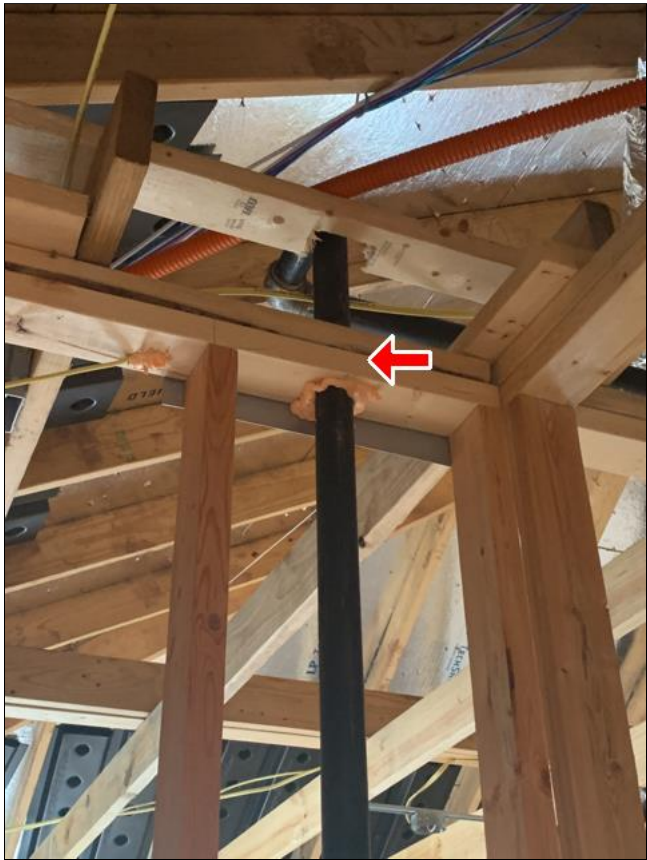
E. Item 4(Picture)

(4) The nail guard is missing over the main gas line at the second floor closet

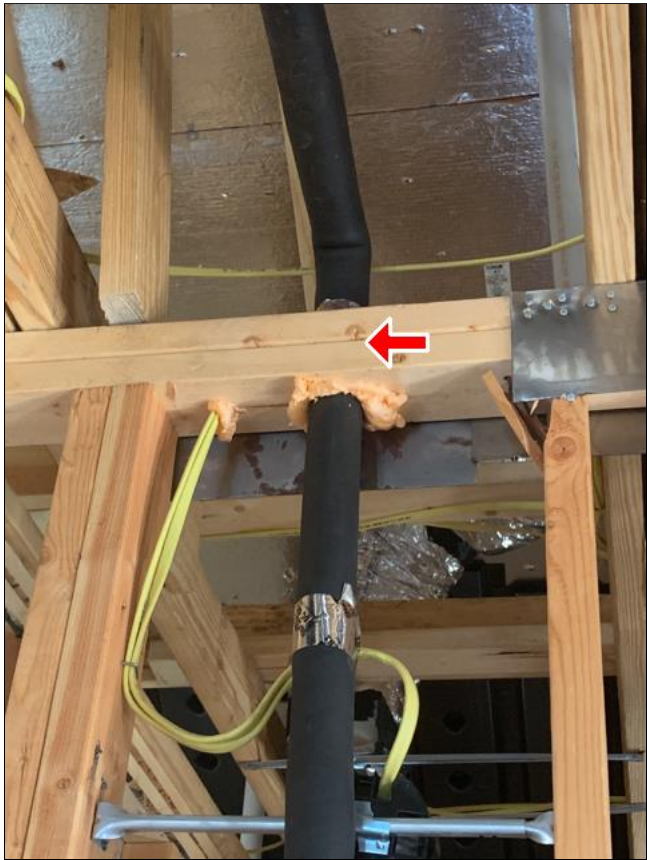
E. Item 5(Picture)

(5) A nail guard is missing over the air conditioning primary drain line above the upstairs bathroom

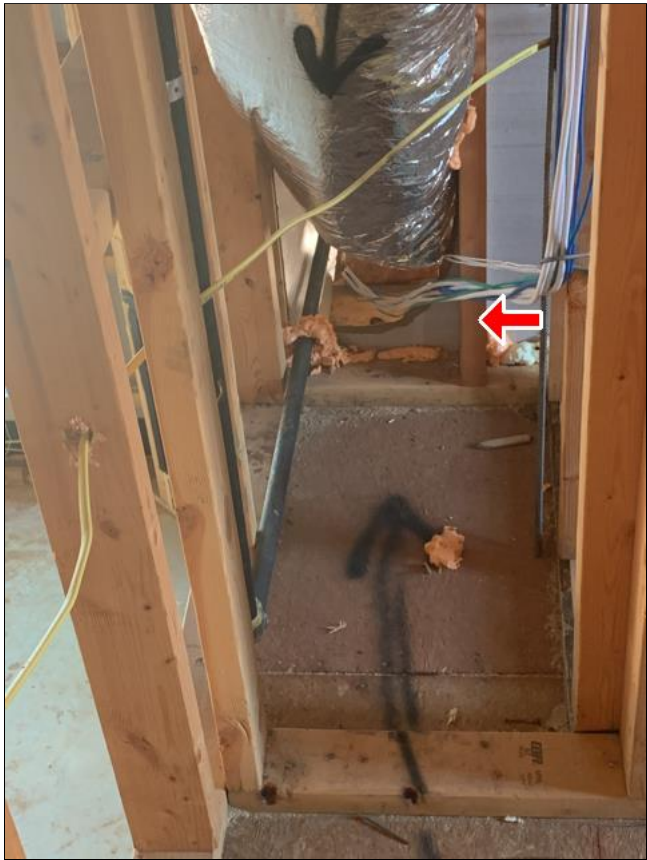
E. Item 6(Picture)

(6) A small section of sheathing is missing around the supply air duct above the master bedroom on the second floor

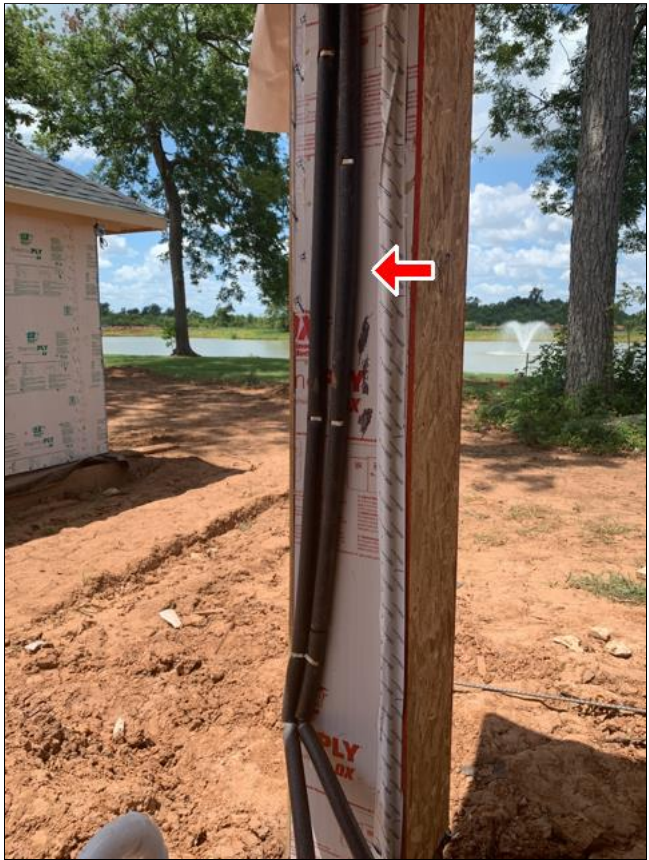
E. Item 7(Picture)

(7) Pex piping is not contained within the column at the corner of the rear porch

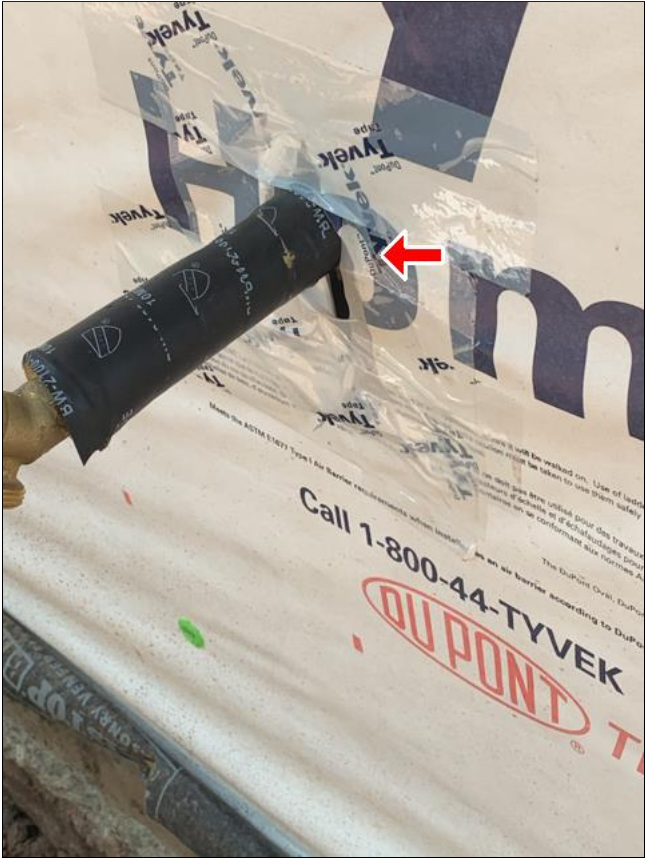
E. Item 8(Picture)

(8) The water line penetration is not properly sealed at the North East exterior wall

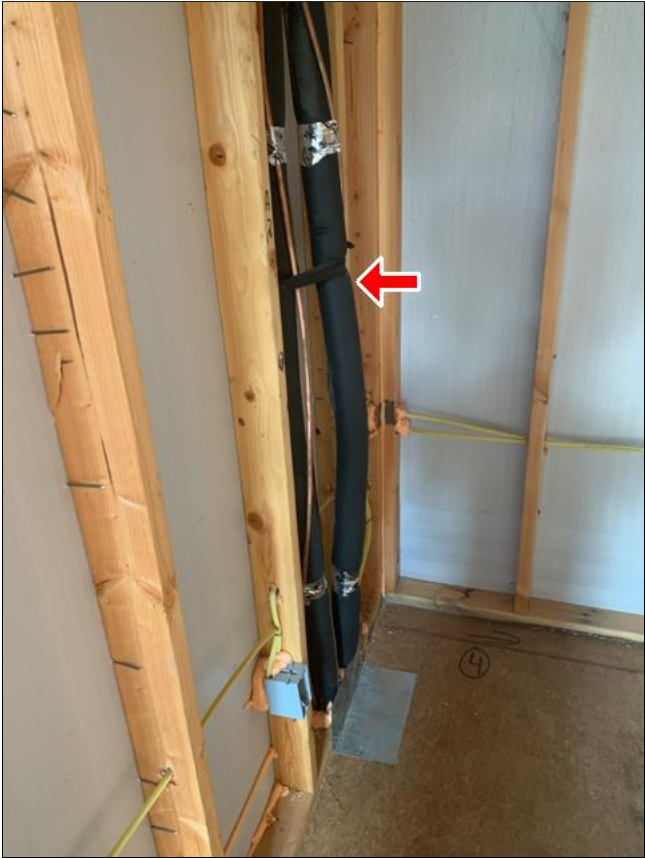
A. Item 1(Picture)

- (2) Refrigerant lines are not contained within the wall space at the second-floor bedroom

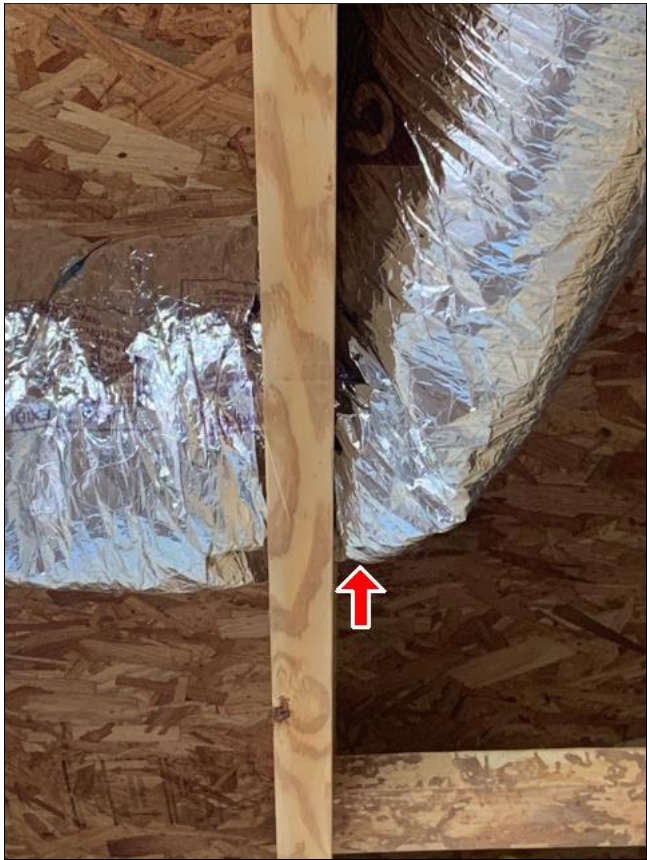
C. Item 1(Picture)

- (1) *Duct systems are inspected for general condition, damage, missing insulation, proper elevation and strapping. The type of ductwork is noted. Improper sizing of ductwork or return air openings may also be noted. Air filters and air registers are also inspected.*
- (2) A flex duct is folded over and restricted at the utility room ceiling

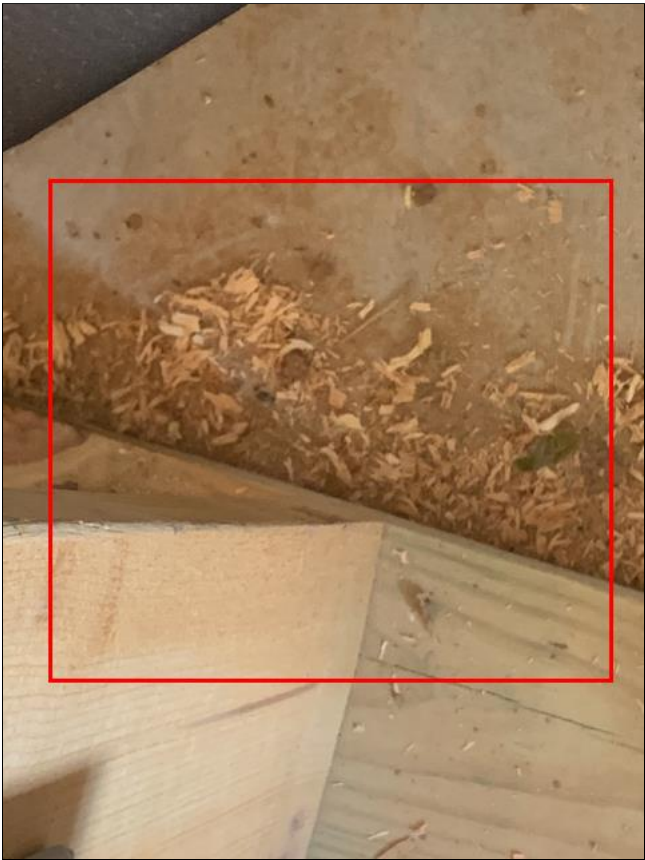
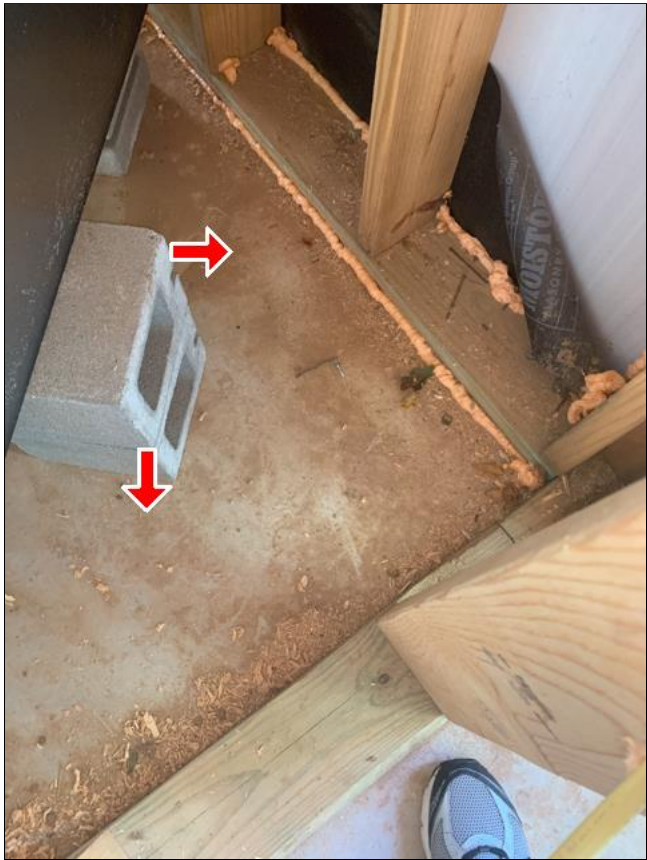
(3) Clean out sawdust and debris from all wall voids prior to sheet rock

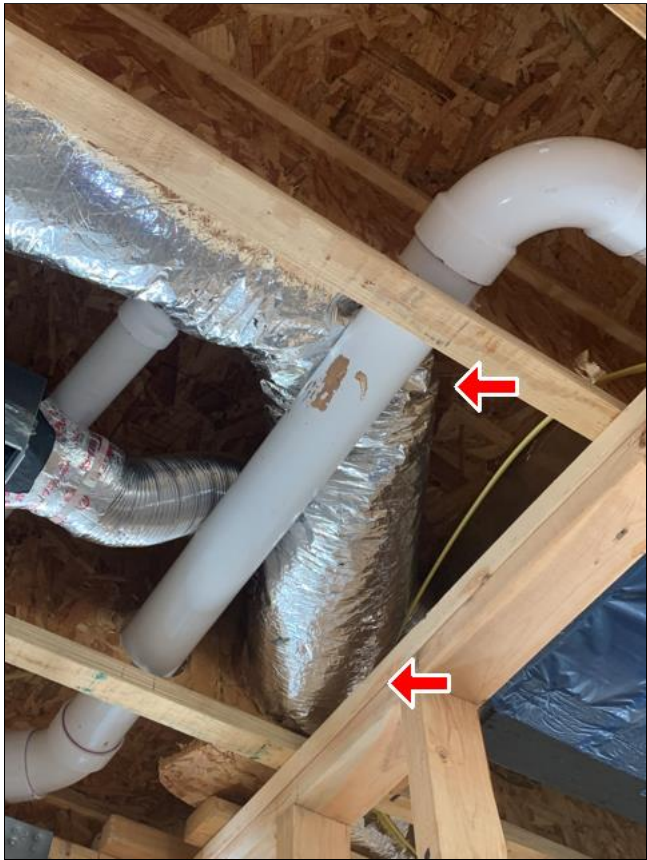
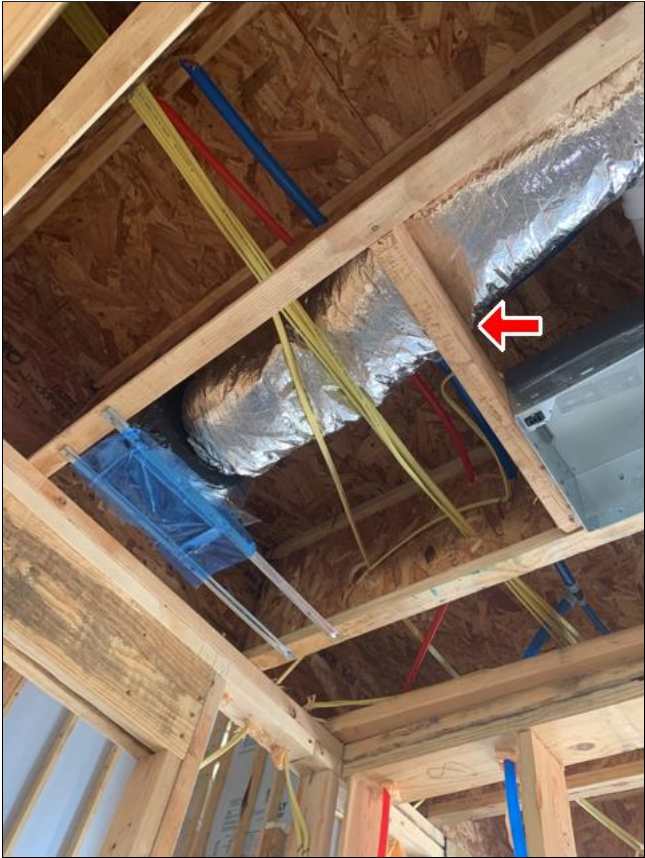
(4) A flex duct is restricted at two locations above the half bath

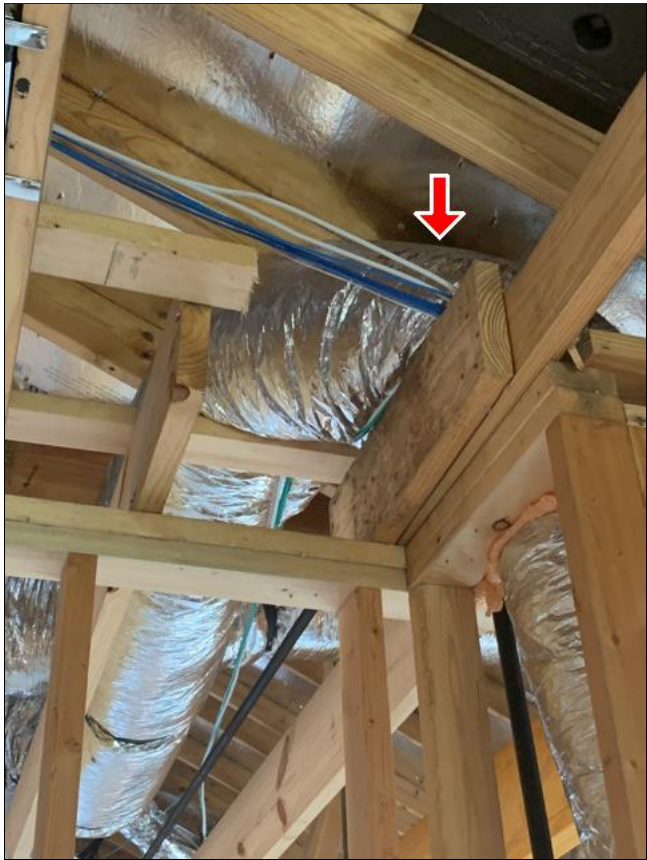
C. Item 6(Picture)

(5) The flex duct to the master bedroom is restricted at the second floor ceiling

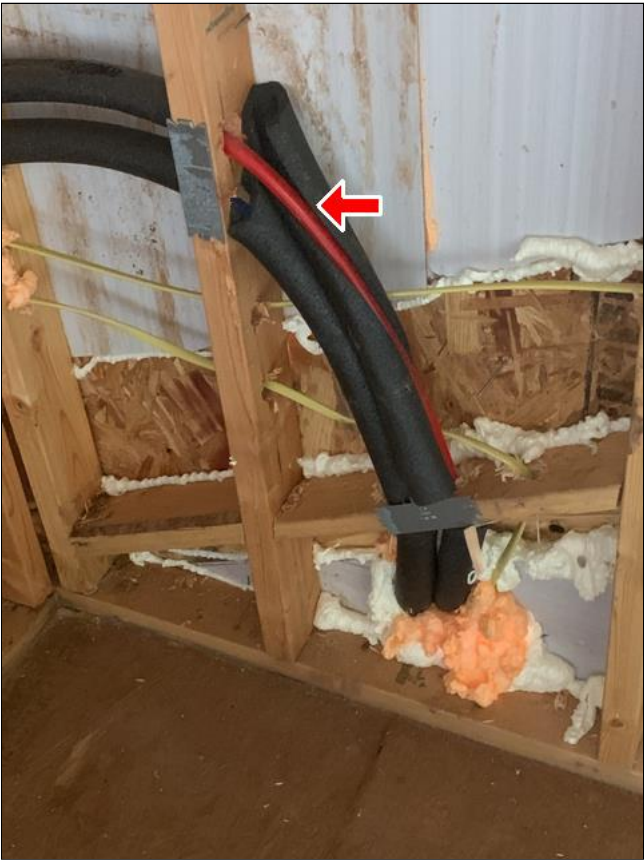
A. Item 1(Picture)

(2) Insulation is not properly installed around the pex piping located at the media room exterior wall

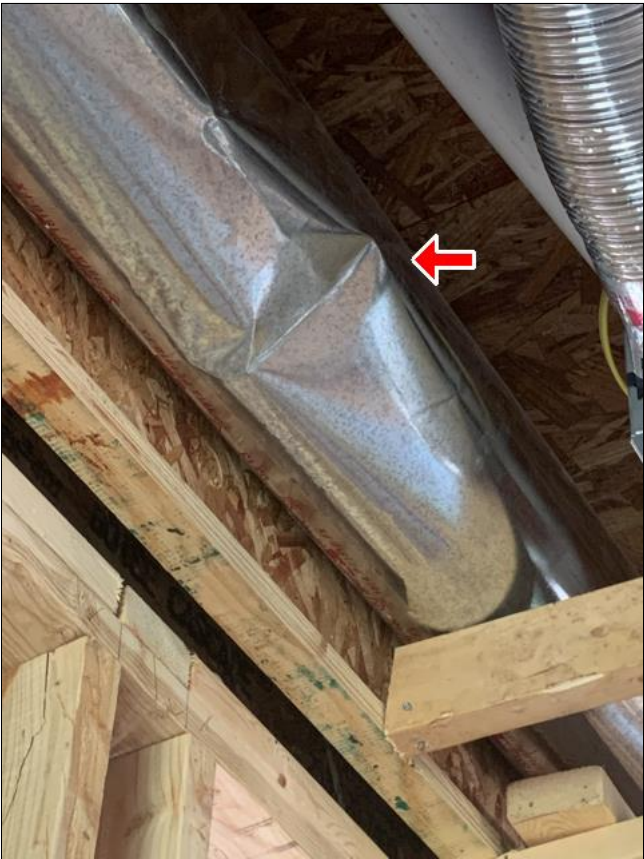
C. Item 1(Picture)

- (1) *Vent hoods and exhaust systems were inspected for proper operation, mounting, and physical condition. The type, condition and termination point of the vent pipe was also inspected.*
- (2) Kitchen exhaust fan vent pipe is damaged in the ceiling area above the half bath
