# Inspection Report

**Property Address:**  
Sample  
Houston TX 77008

# PROPERTY INSPECTION REPORT

**By:** TREC#'s 288, 21245, 21907 / ABET Home Services 10/10/2019

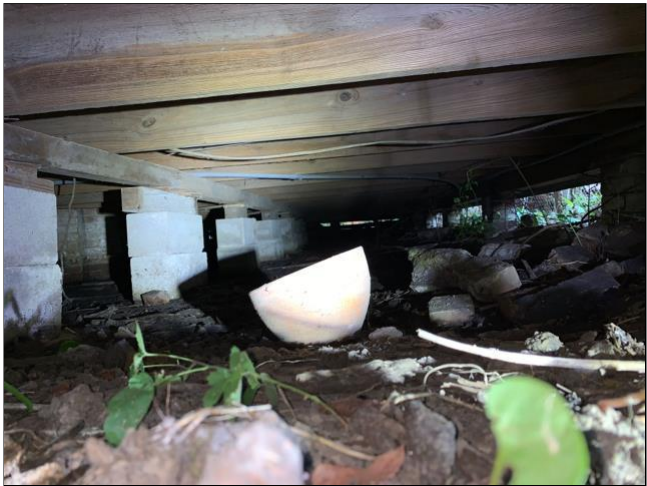
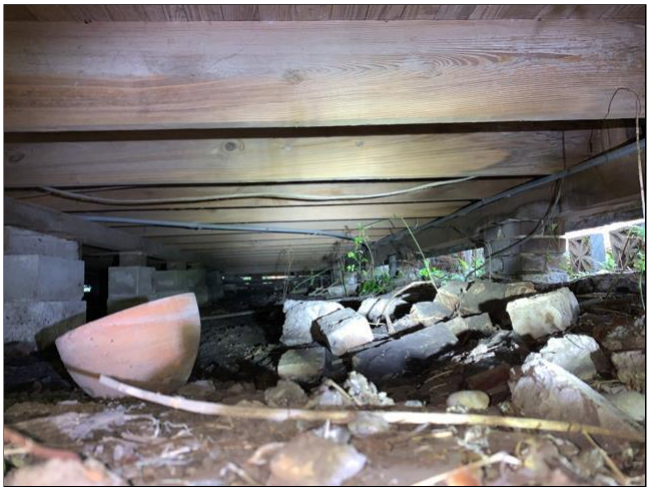
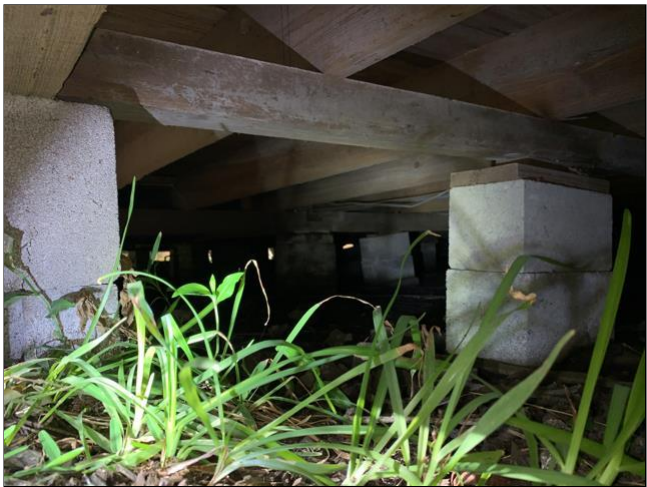
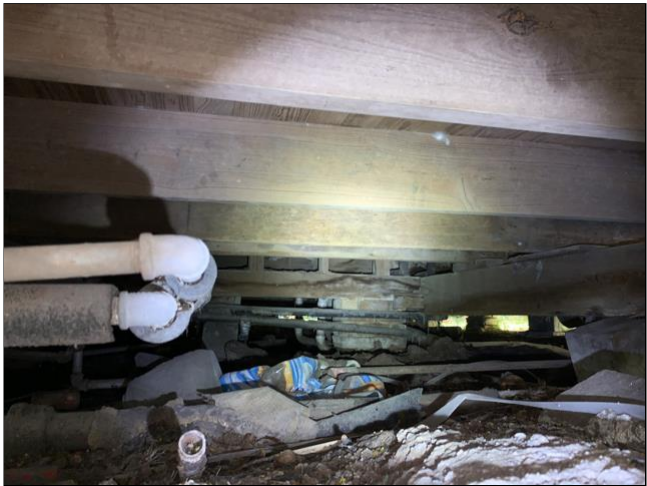
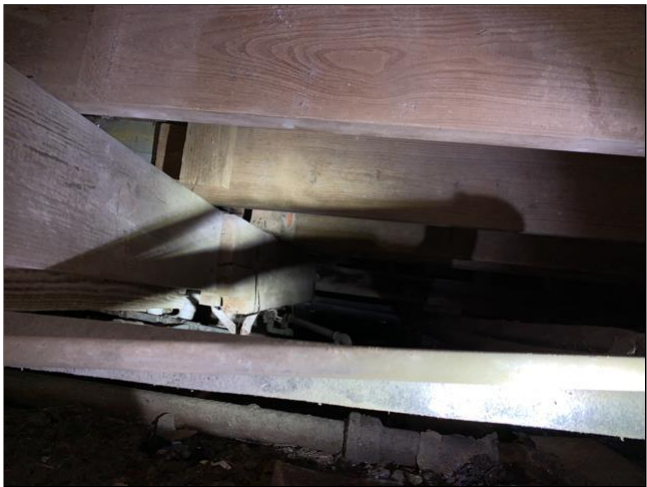
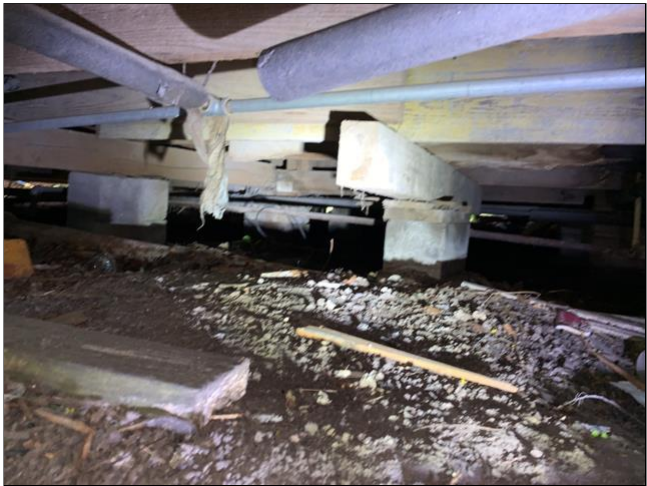
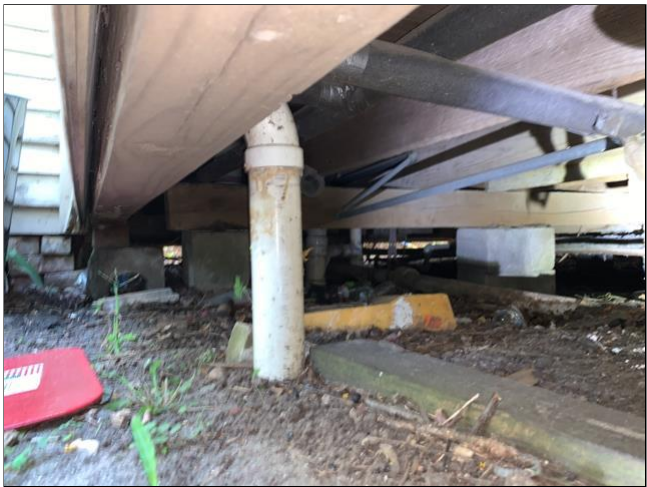
Significant signs of structural movement noted; suggest that an expert in this field be consulted for further evaluation of the foundation and to provide suggestions as to what corrective actions should be taken.

(2) And excessive amount of debris was observed beneath the home. Several of the piers are tilted and are not installed completely vertical. The beams in the subfloor appeared to be in overall good condition. The foundation of the home was viewed from the perimeter of the house only. Access beneath the home is very limited

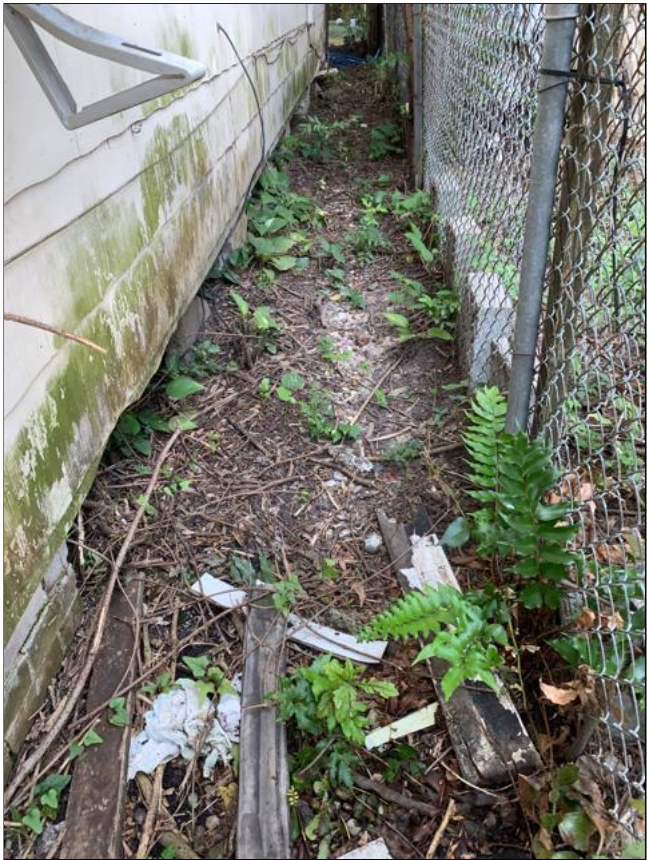
B. Item 1(Picture)

Grading does not slope away from foundation 6" within the first 10'

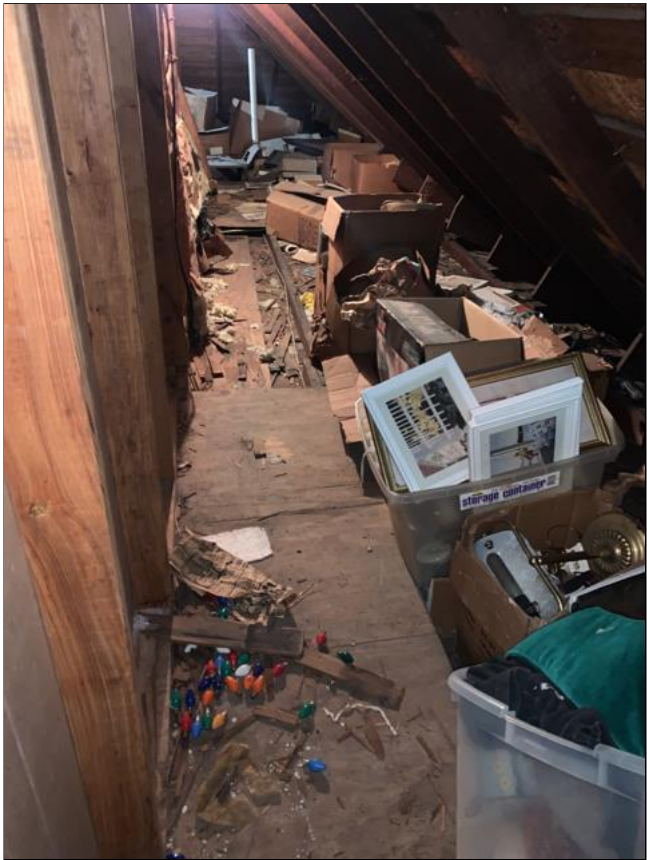
D. Item 1(Picture)

Excess amount of debris was observed in attic. Unnecessary debris should be removed to help prevent damage to insulation, reduce the proper ventilation and eliminate possible fire hazard concerns.

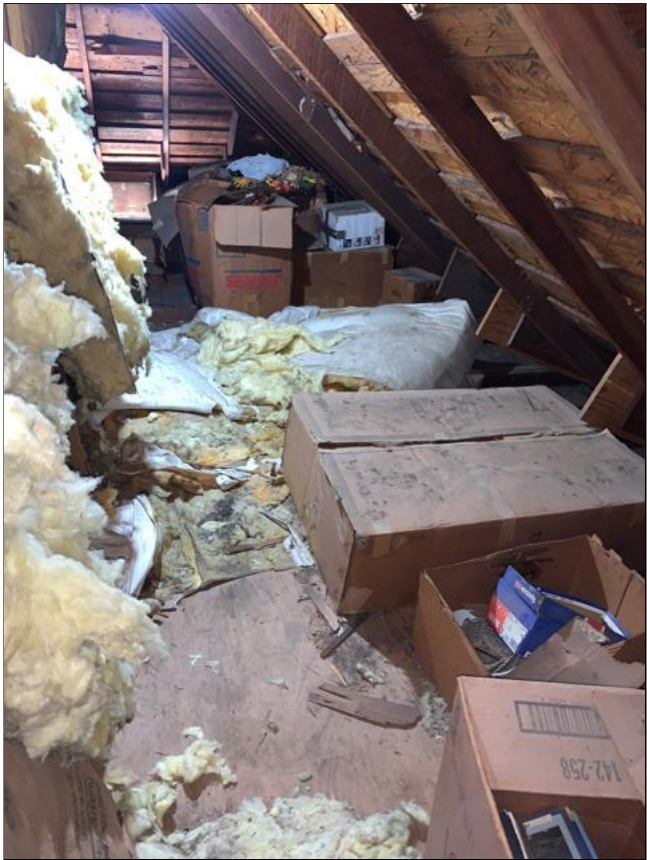
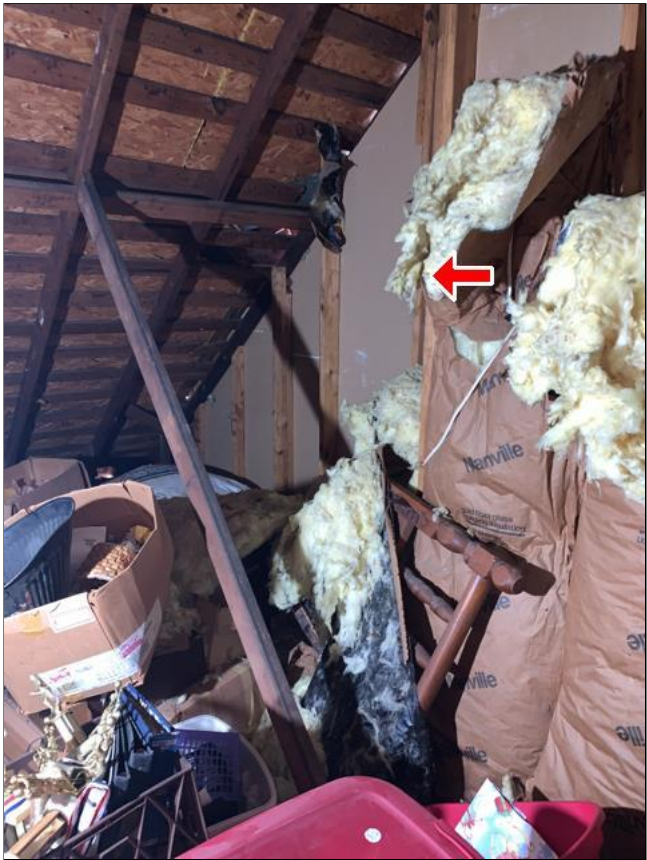
(2) Vertical wall insulation is missing and damaged at the upstairs attic space

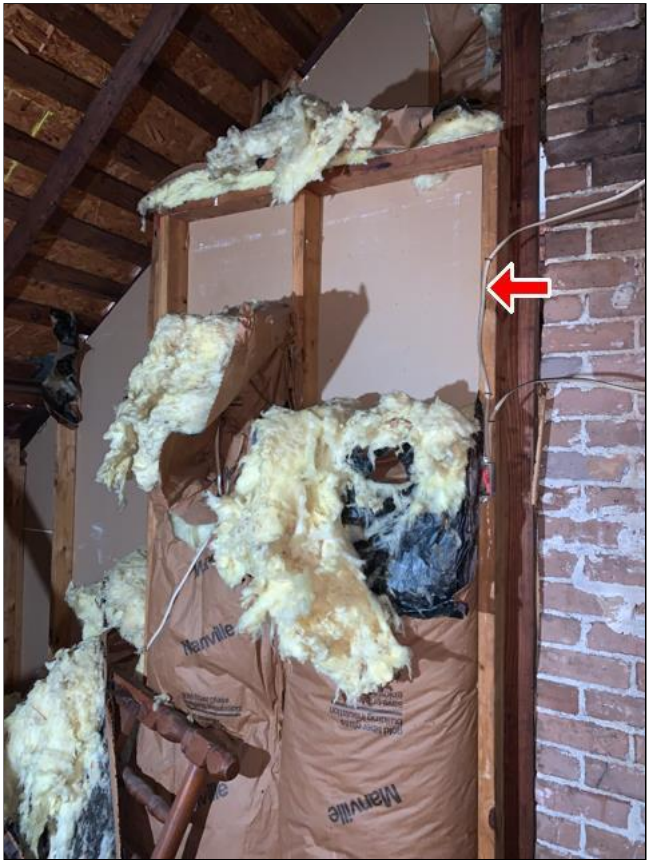
D. Item 4(Picture)

(3) Insulation is missing on the attic floor at most locations throughout the house

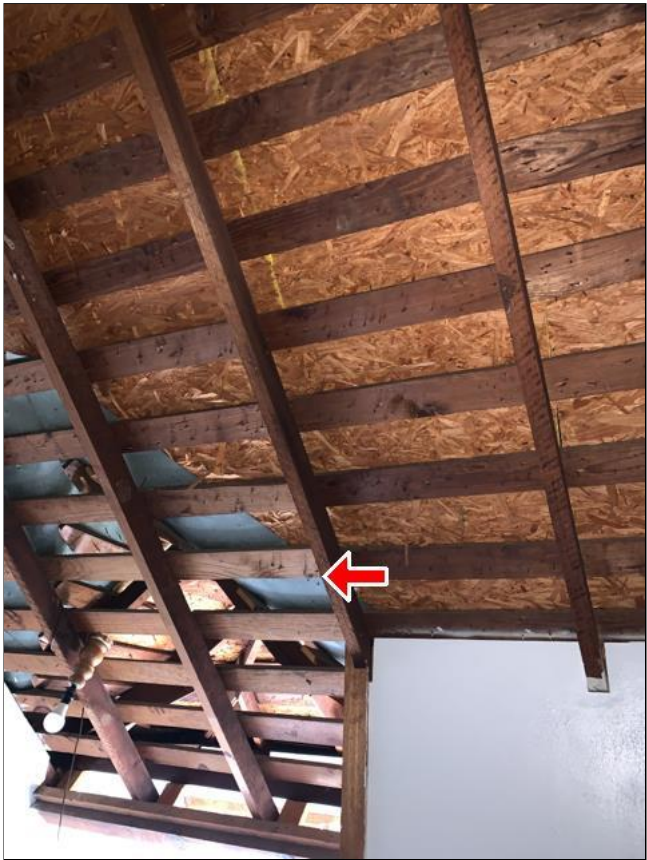
D. Item 6(Picture)

(5) Attic ventilation does not appear to be adequate. One square foot of ventilation is recommended for every 300 square feet of attic space.

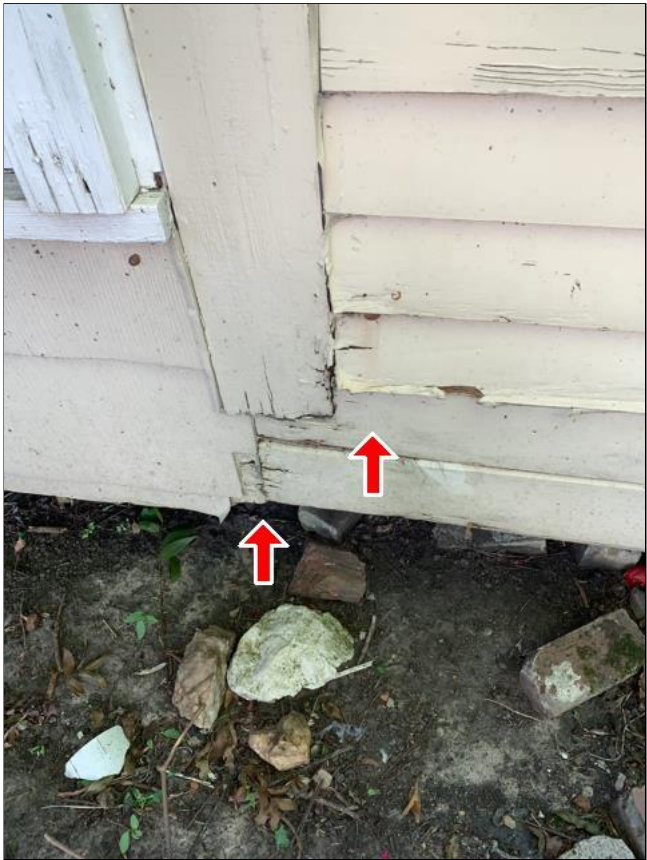
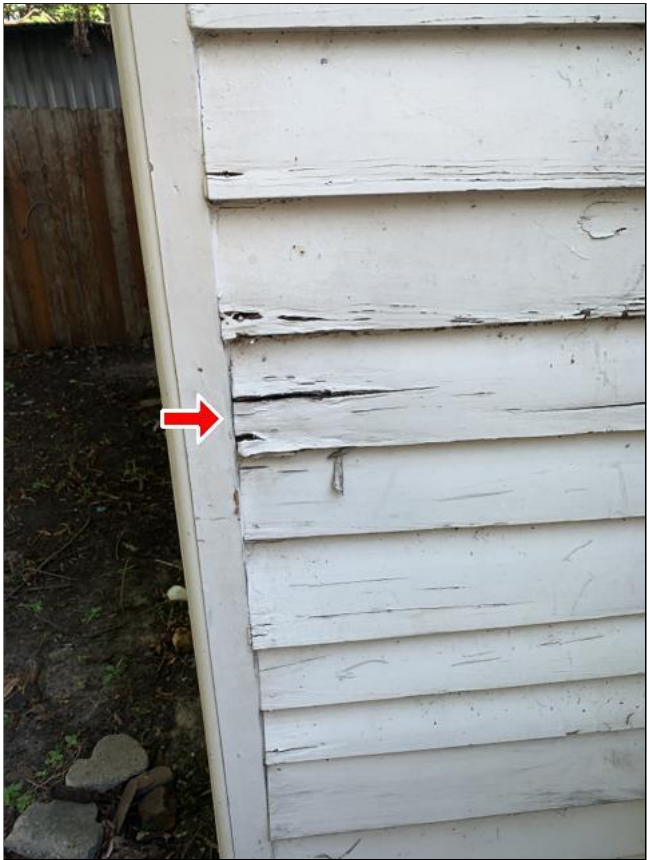
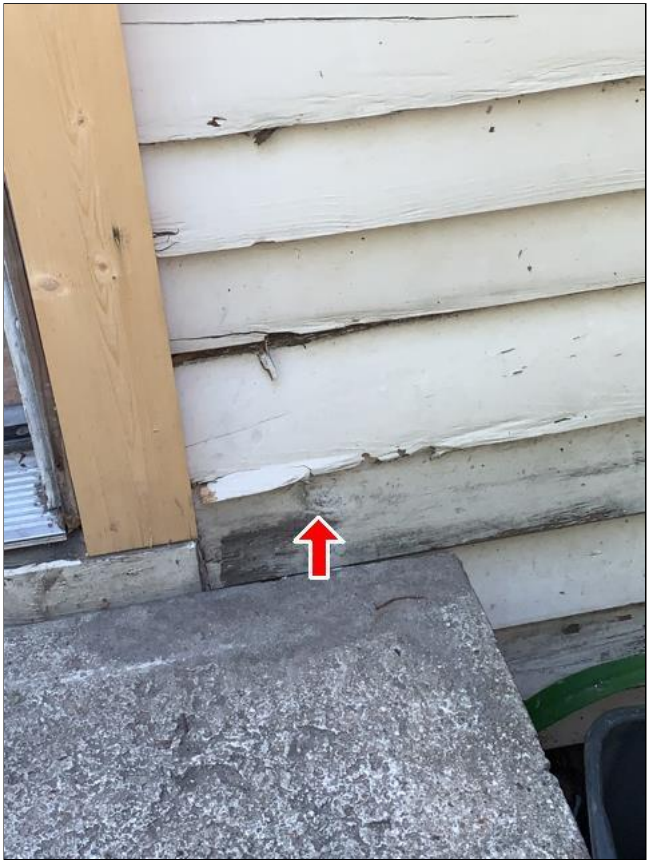
(2) Deteriorated wood siding was observed at the rear walls

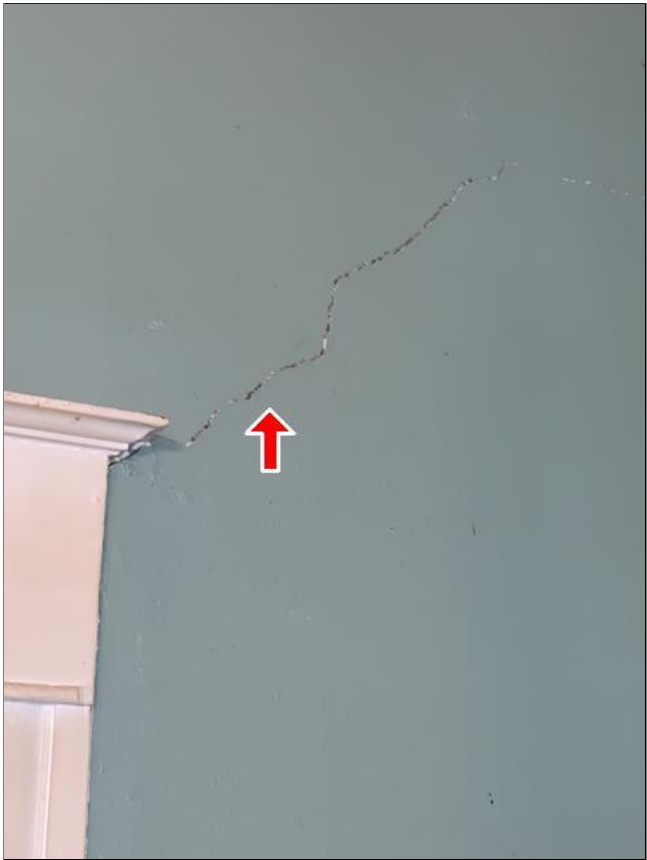
E. Item 4(Picture)

(3) Damaged sheet rock was observed at the dining room

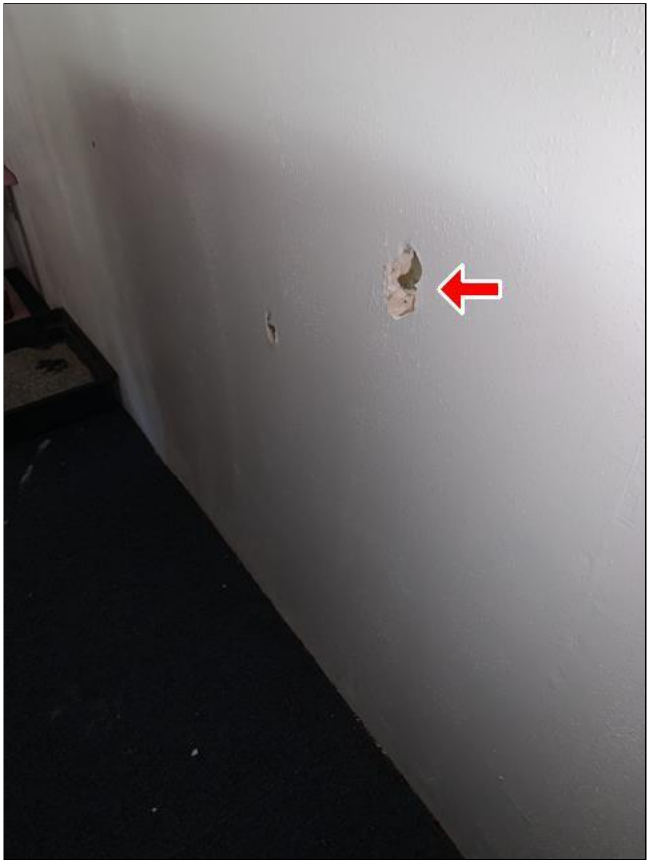
E. Item 5(Picture)

(4) Damaged sheet rock was observed at the upstairs bedroom

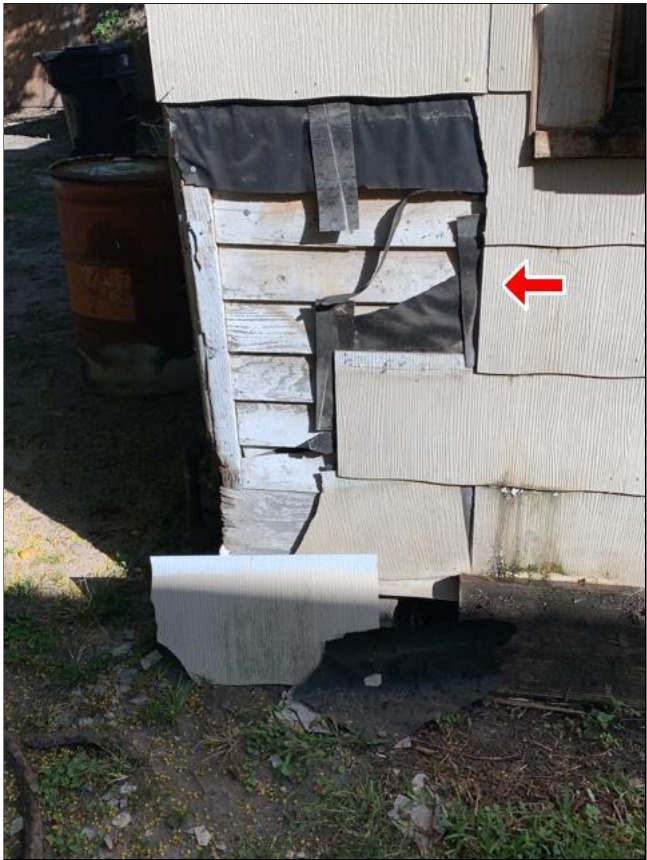
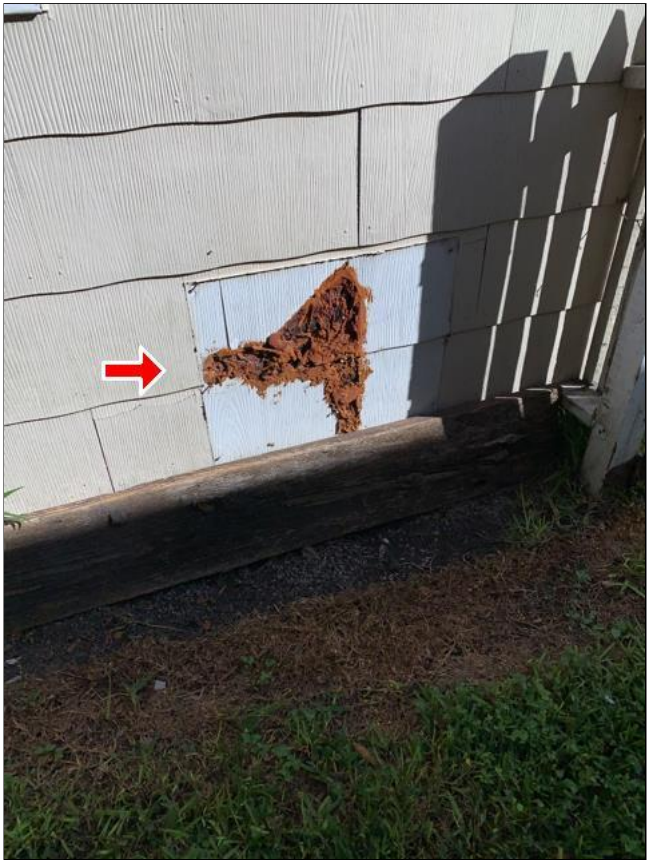
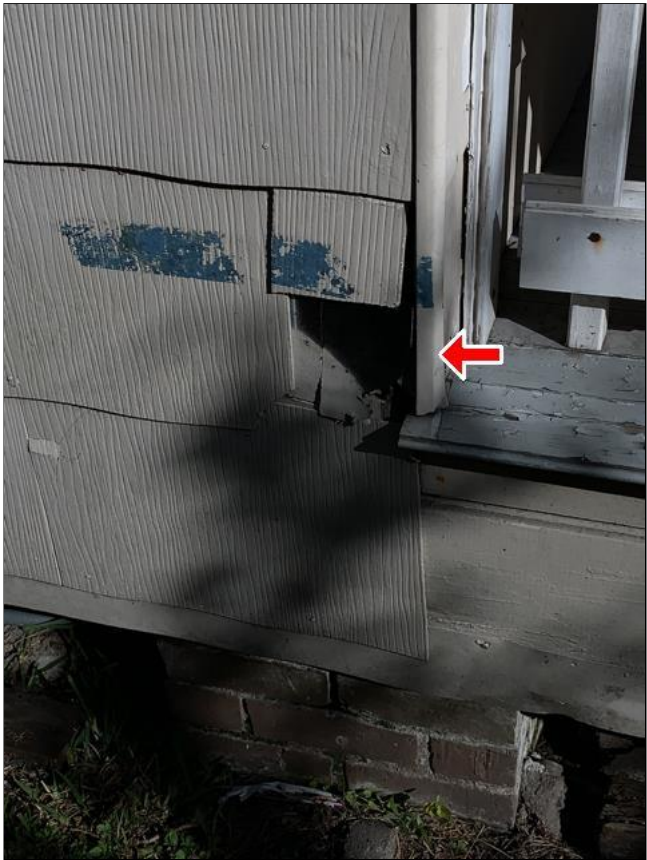
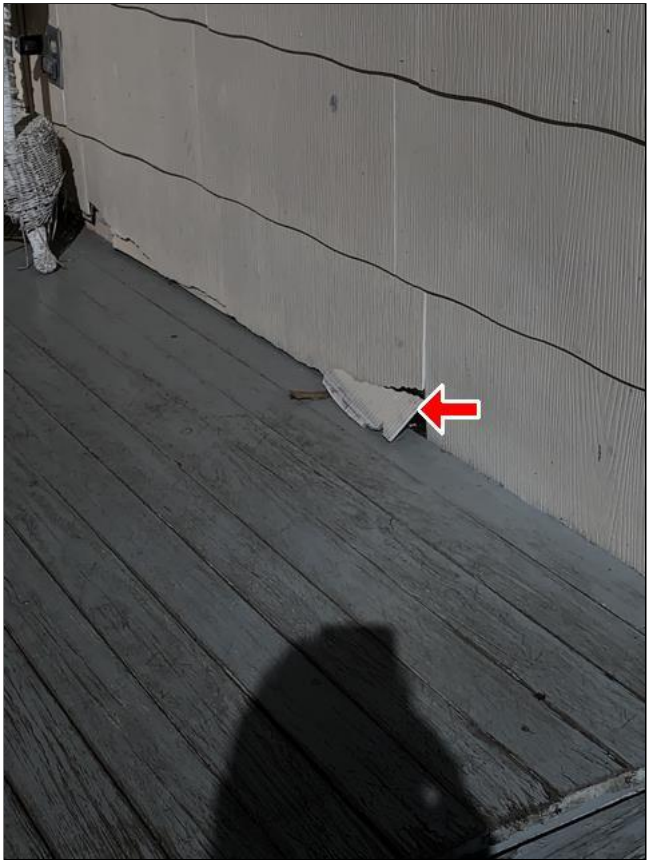
(5) The asbestos shingles and siding is damaged and missing at the south wall and at the front porch

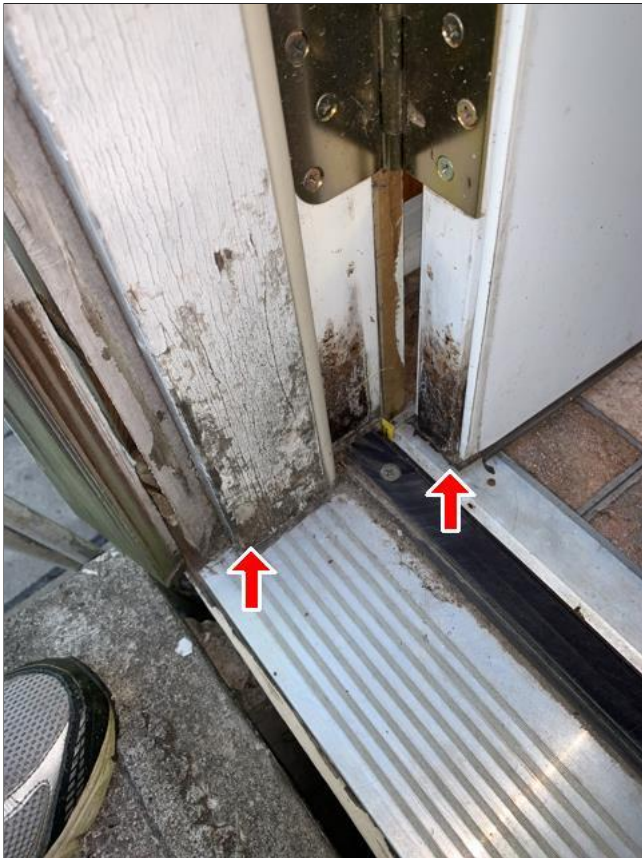
G. Item 1(Picture)

Comments:  
(1) *All interior and exterior doors were checked for proper latching and proper fit and operation in door frames. Attic and exterior doors were inspected for proper weatherstripping. Installation of safety glass in exterior doors was verified. All exterior doors were inspected for proper operation. Wood frame doors were inspected for wood rot and deterioration. All exterior doors were checked for signs of water penetration.*  
(2) *The rear entry door and door frame are deteriorated at the bottom*

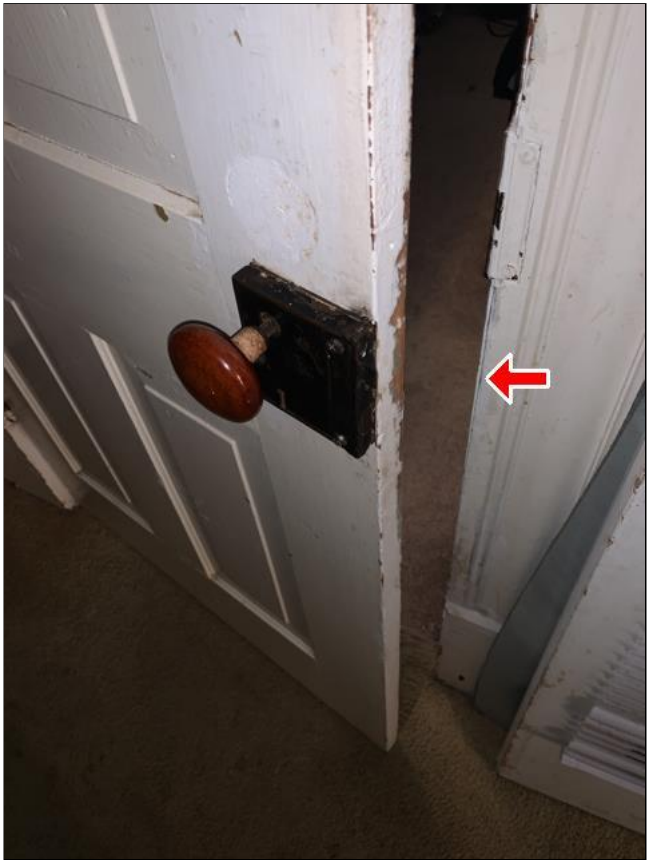
G. Item 2(Picture)

(3) The rear bedroom entry door knob requires repair

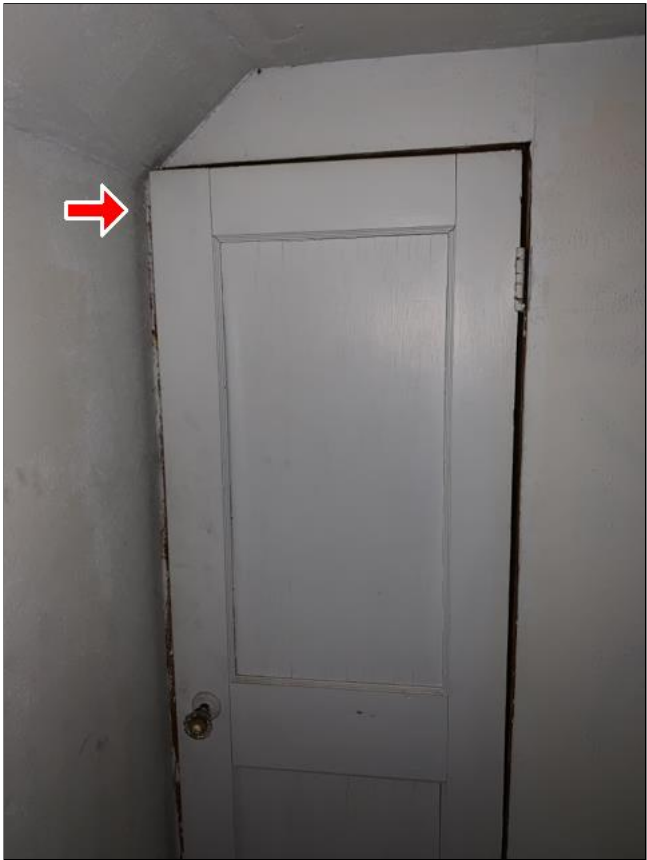
G. Item 3(Picture)

(4) The attic access door does not close and it's not weatherstripped

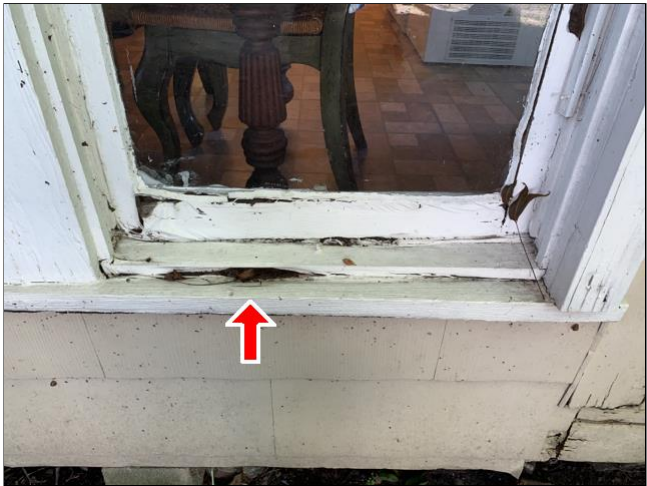
H. Item 1(Picture)

- (1) *All easily accessible windows throughout house were manually operated. The type of windows installed were identified. Windows were visually inspected for breakage, water penetration and caulking. Locks and latches on easily accessible windows were inspected. Double pane windows were visually inspected for signs of fogging between panes. Identification of failed seals is limited if windows require cleaning. Missing and damaged window screens are noted.*
- (2) The window frame at the rear wall to the breakfast room is badly deteriorated

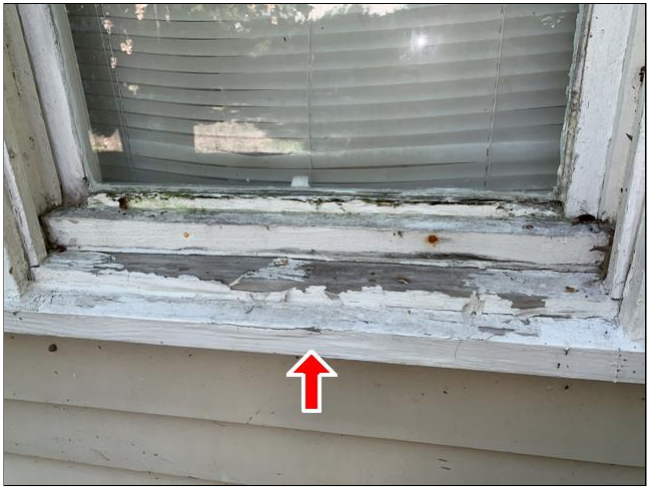
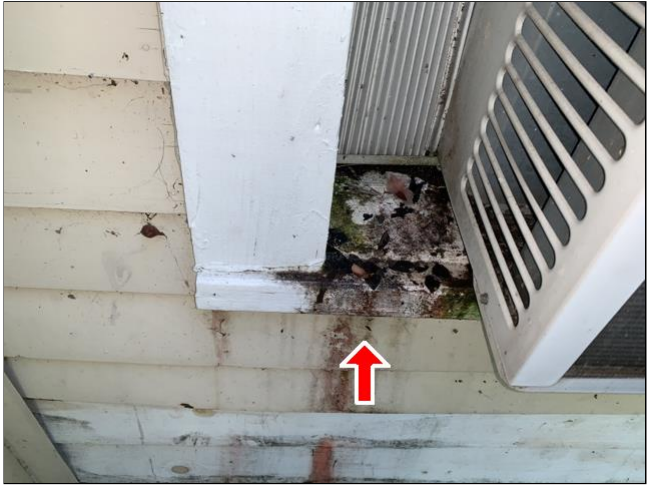
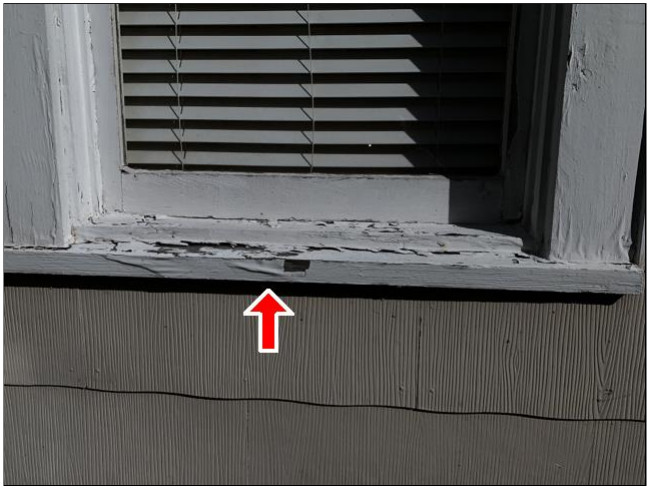
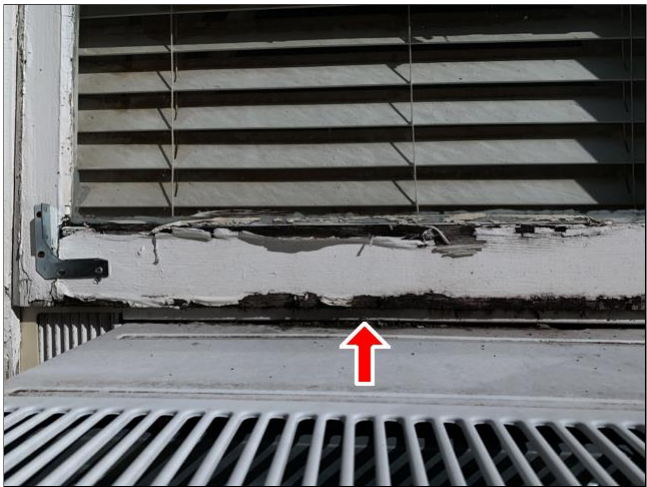
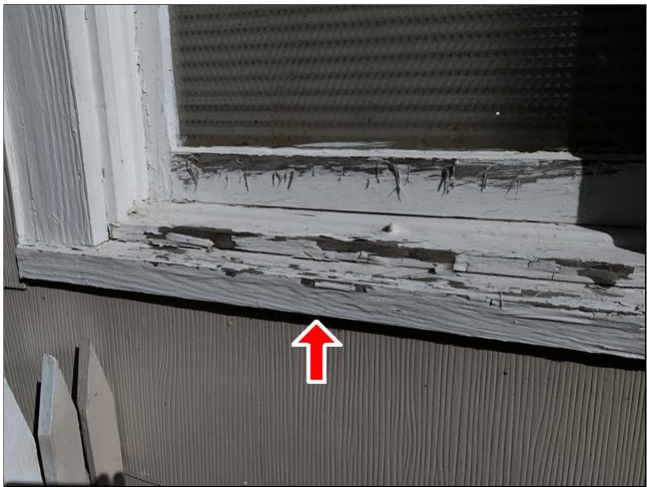
(3) Window frames are deteriorated at the rear wall and the south wall

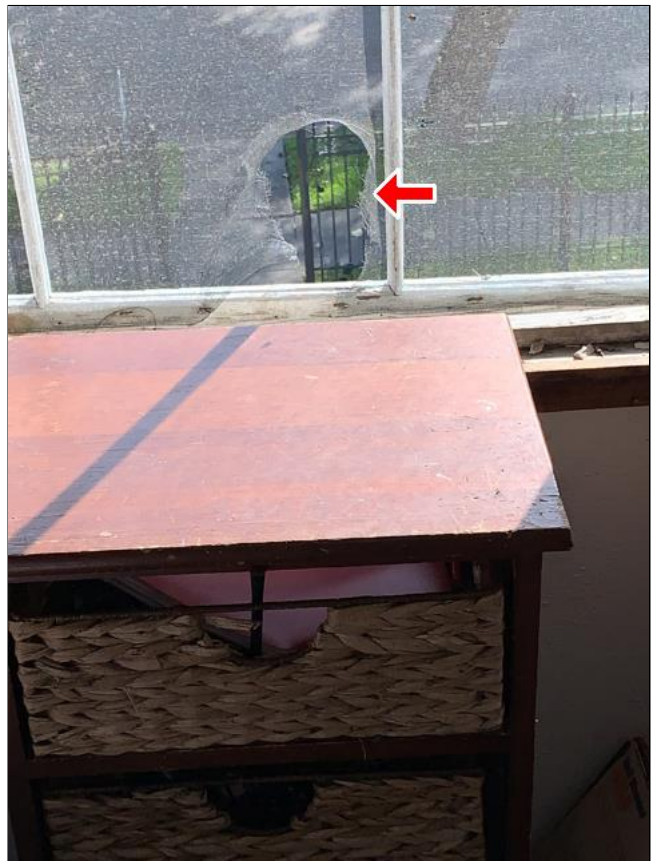
H. Item 7(Picture)

Bedroom windows should be operable for egress from the home in the event of an emergency  
(5) The window screen is damaged at the upstairs bedroom

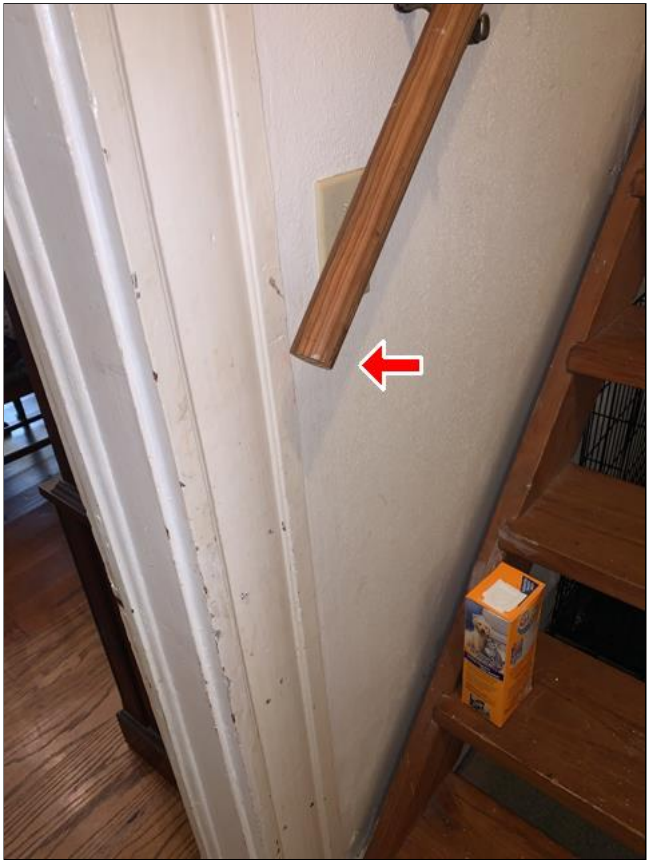
I. Item 1(Picture)

- Comments:
- (1) *Stairways were inspected for proper installation and location of handrails, baluster installation and spacing and proper dimension of stair tread.*
  - (2) Hand railing is not terminated to wall

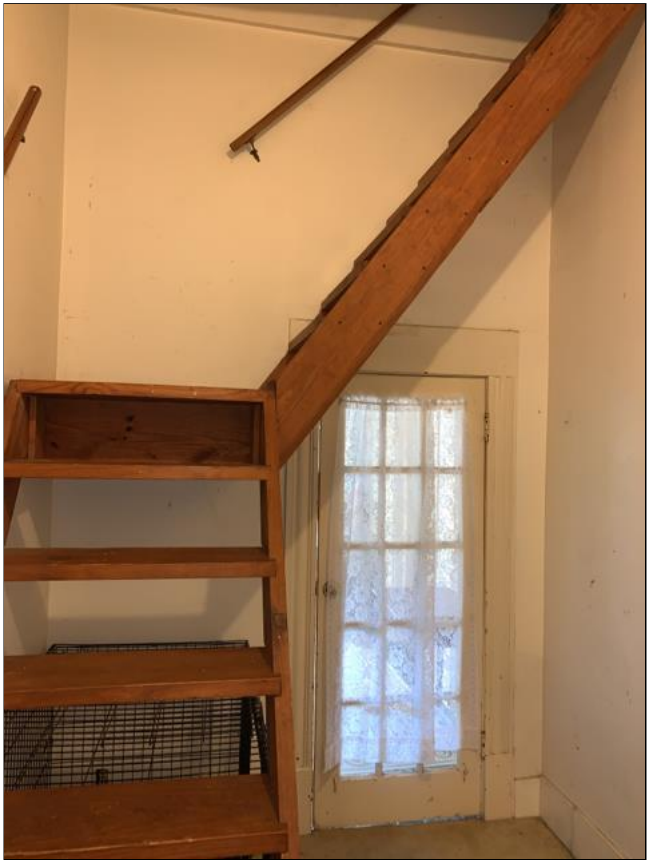
I. Item 2(Picture)

(3) Hand railing is loose/missing

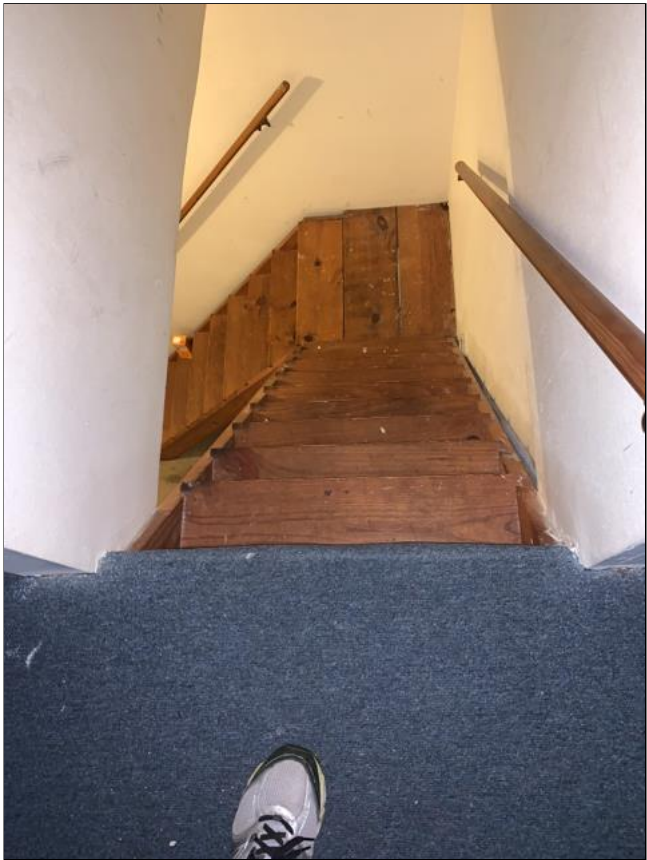
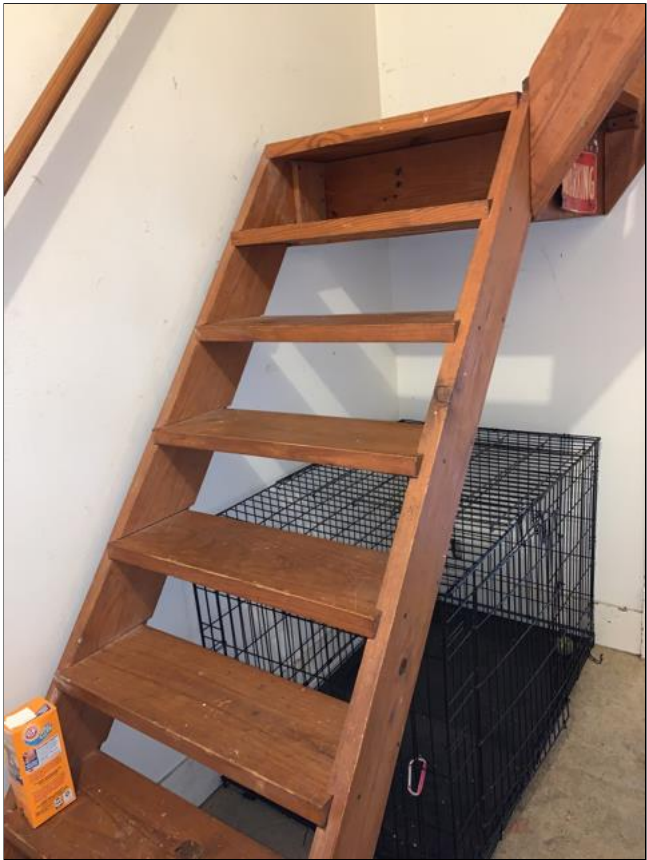
(4) Improper dimensions of stair risers greater than 7 3/4"

Improper dimensions of stair treads less than 10"

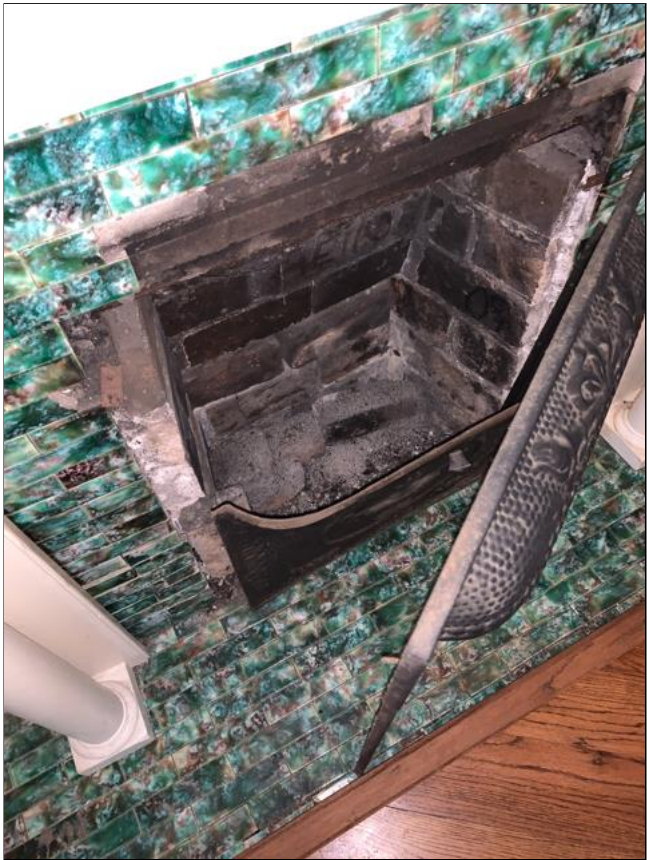
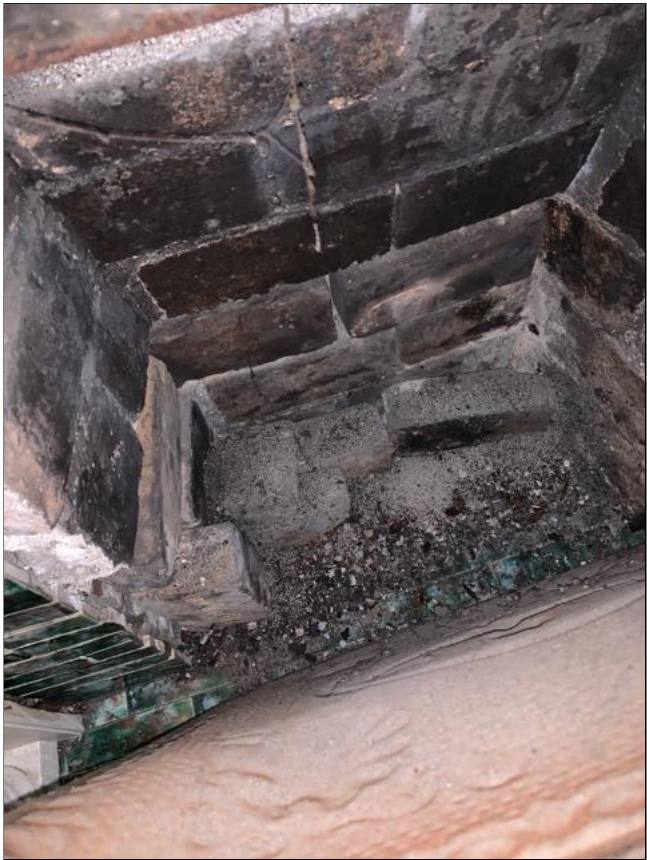
(2) The small fireplace does not appear to be safe to use. Fire brick are loose and missing. The damper is not operational. Further investigation is needed

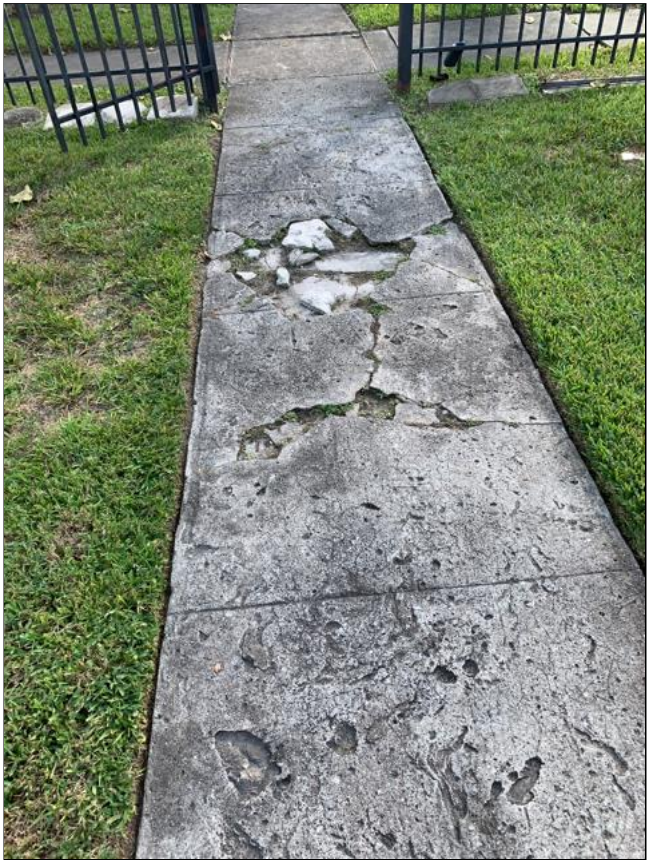
L. Item 1(Picture)

(2) Driveway or sidewalk is cracked at multiple locations

Cracks or separations in driveway or sidewalk exceed 1" in height or separations - This is considered a trip hazard

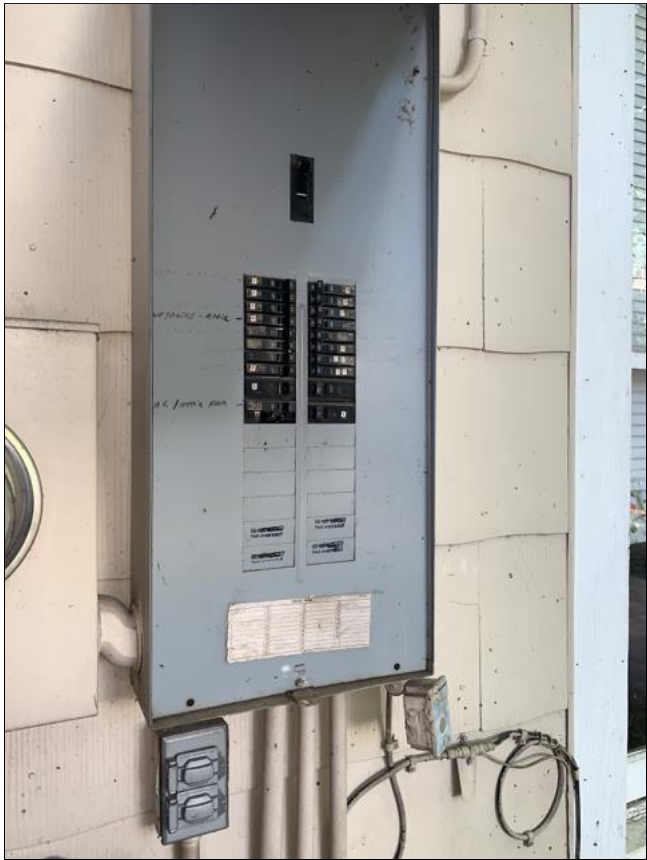
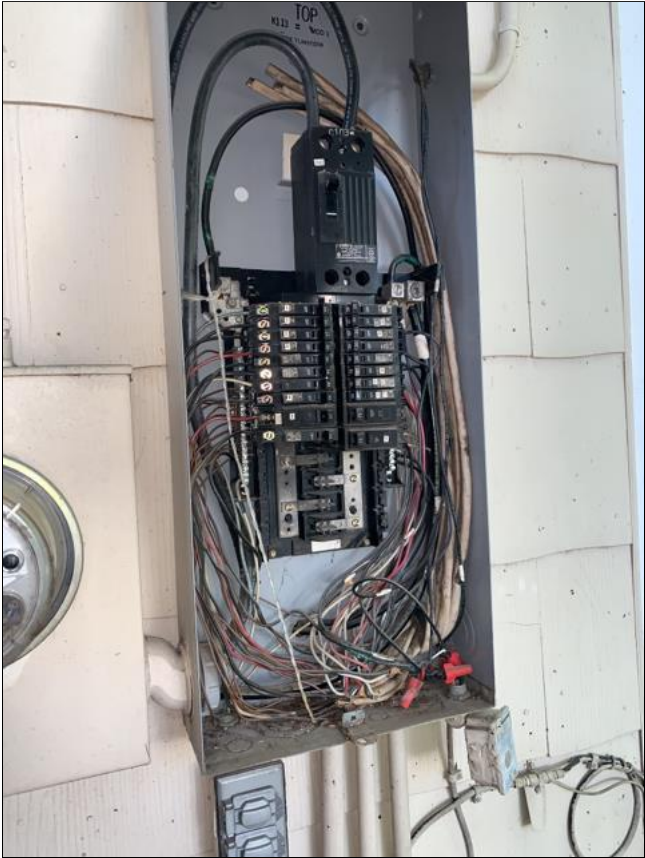
- (2) Ground wire and ground rod are not visible
- (3) Panel is not labeled at all locations

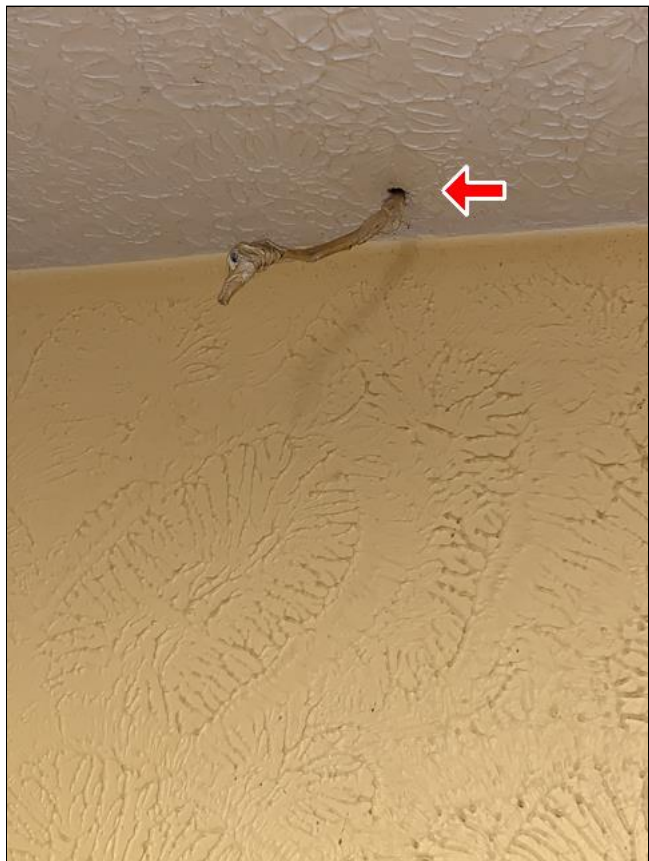
B. Item 1(Picture)

- (2) The kitchen counter outlets are not GFCI protected
- (3) There is an improperly terminated wires at the ceiling above the cooktop

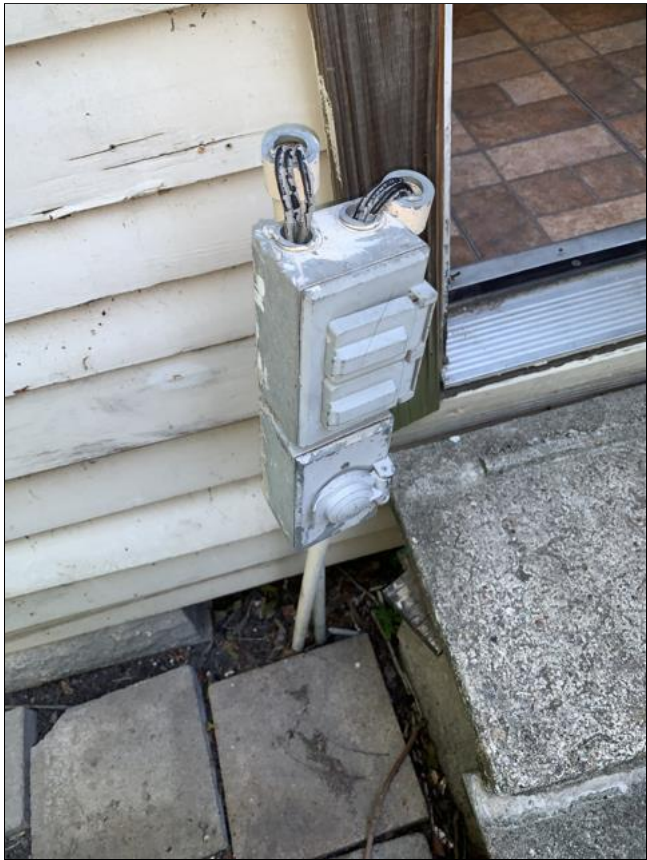
B. Item 2(Picture)

- (4) The exterior junction Boxes at the rear porch are not connected to the conduit. The exterior outlets are also not GFCI protected

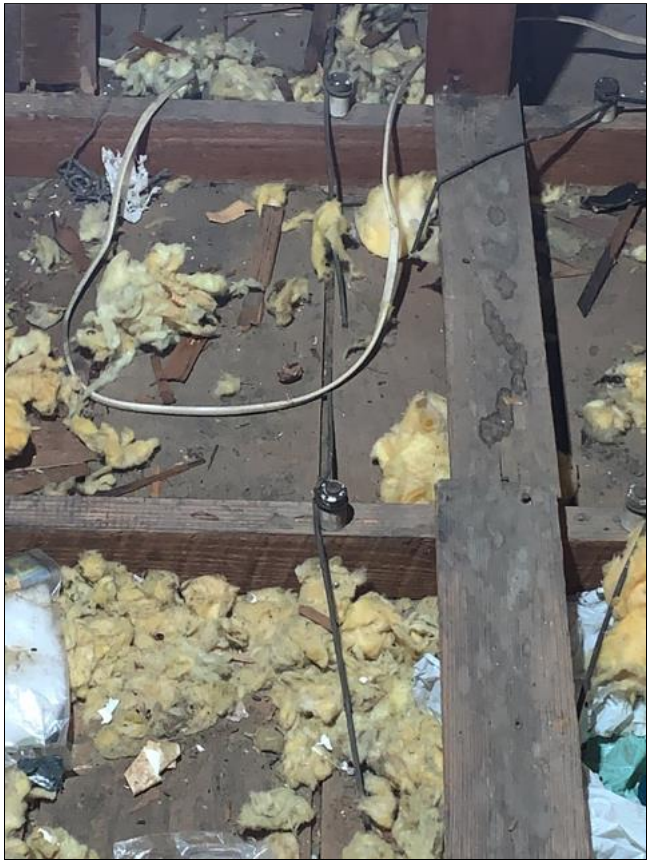
B. Item 3(Picture)

(5) The original knob and tube wiring was observed at multiple locations throughout the Attic space and appears to be still in use. This wiring is now considered to be unsafe and should be replaced

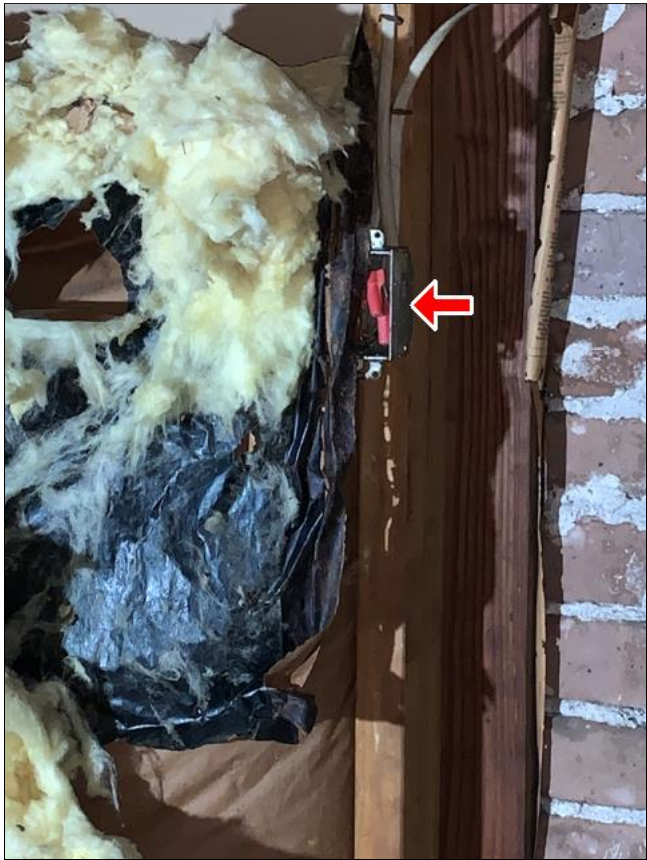
B. Item 4(Picture)

(6) Junction box covers were observed to be missing at multiple locations in the attic space
