# Inspection Report

**Property Address:**  
Sample  
Houston TX 77008

# PROPERTY INSPECTION REPORT

**By:** TREC#'s 288, 21245, 21907 / ABET Home Services 10/10/2019

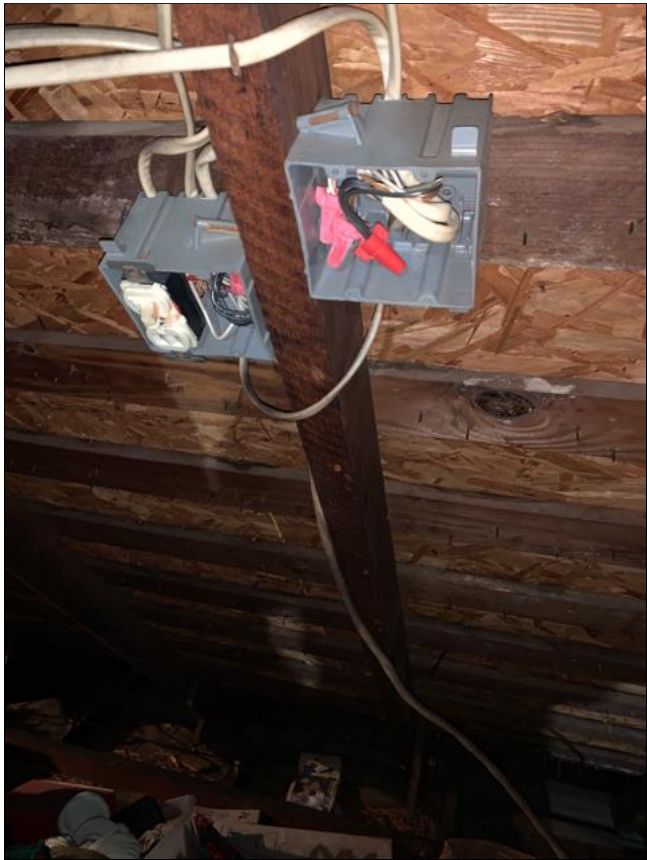
B. Item 5(Picture)

(7) No GFCI protection at one or more locations - This is considered a recognized safety hazard

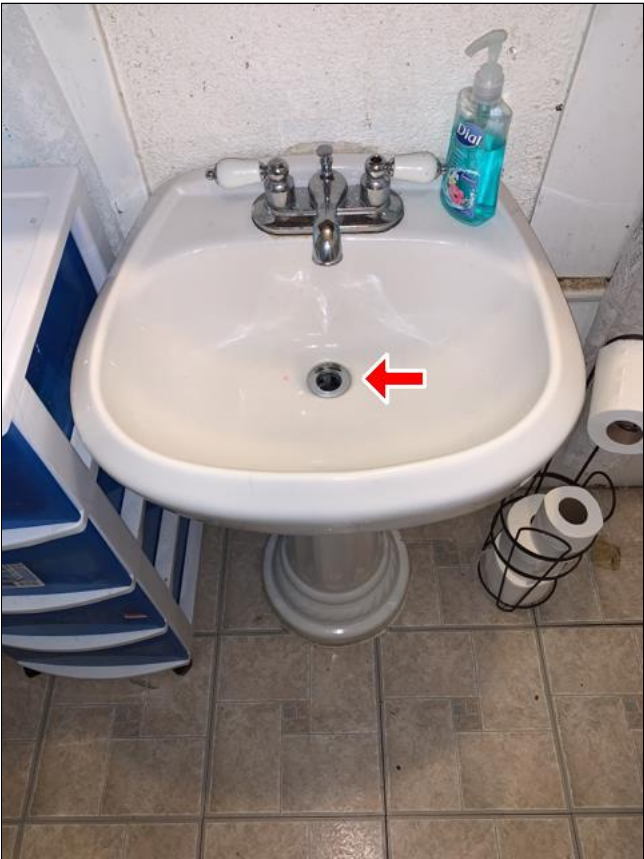
A. Item 1(Picture)

- Comments:
- (1) *The location of the water meter, location of the house shut off valve, water pressure to the house and type of plumbing piping is noted. All faucets and plumbing fixtures were operated manually and inspected for proper operation and leakage where accessible. Visible plumbing beneath sinks or vanities was also inspected for general condition and leakage. In most cases shut-off valves beneath sinks were not operated due to the risk of causing leakage. Tub and shower enclosures were inspected for proper caulking, condition of tiles and water penetration*
- (2) The sink stopper at the rear bathroom vanity is not working

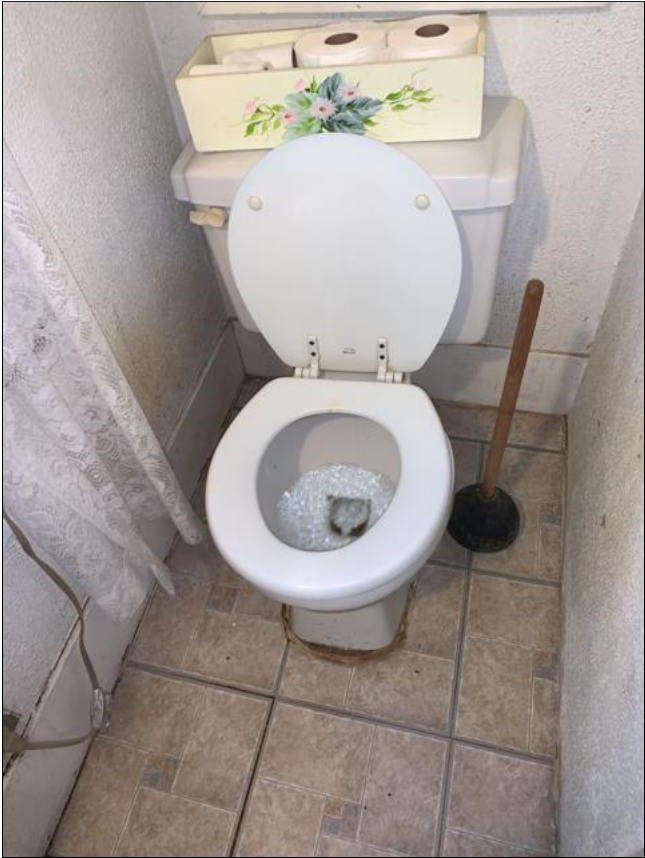
A. Item 2(Picture)

- (3) The rear bathroom toilet is loose on the floor

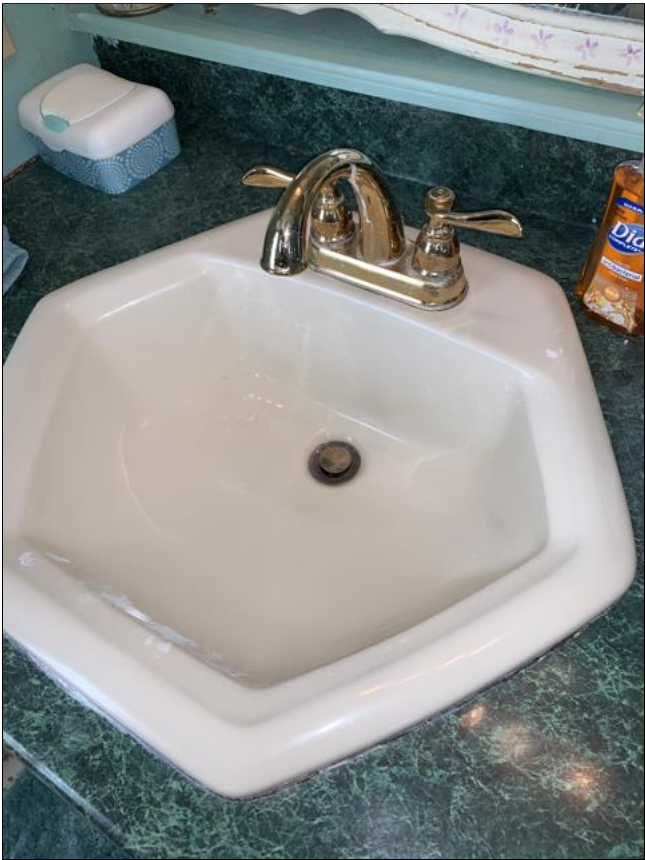
A. Item 3(Picture)

(4) The master bathroom vanity faucet is leaking

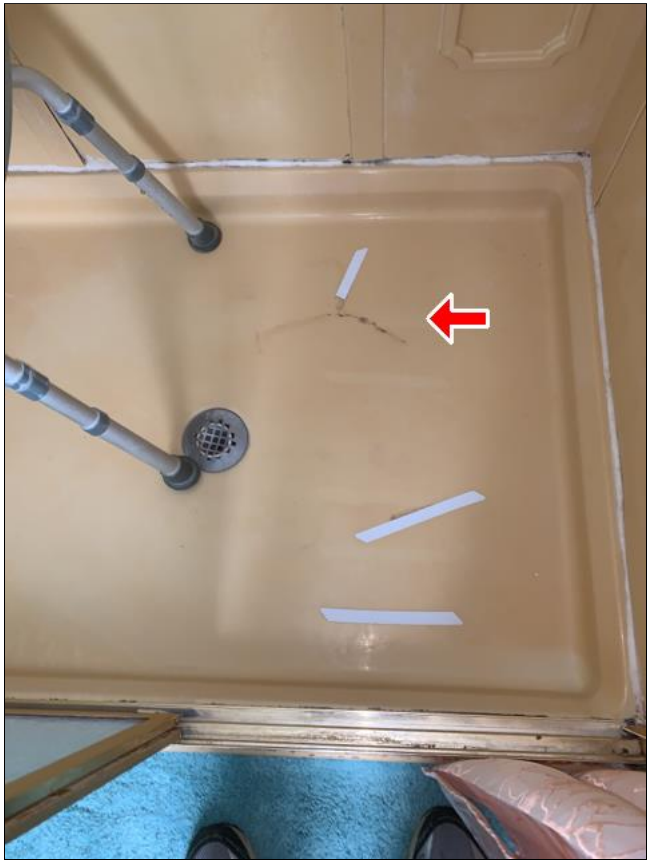
A. Item 4(Picture)

(5) The master bathroom shower floor is cracked and is probably leaking. Further investigation is needed

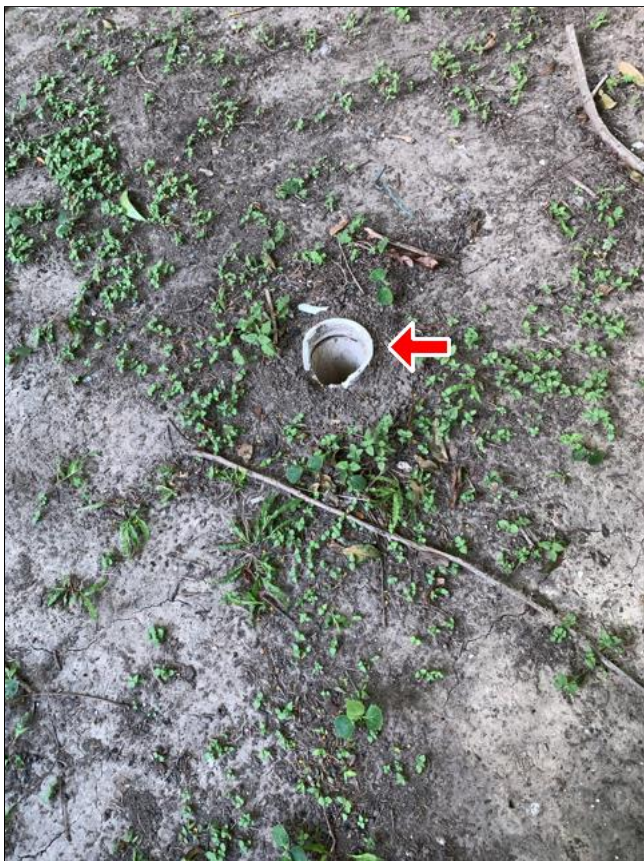
B. Item 1(Picture)

- (1) *Drains are tested by running a normal amount of water from associated fixtures. Underground or under-slab drain systems were not inspected.*
- (2) The clean out cap And piping is broken at the center of the backyard

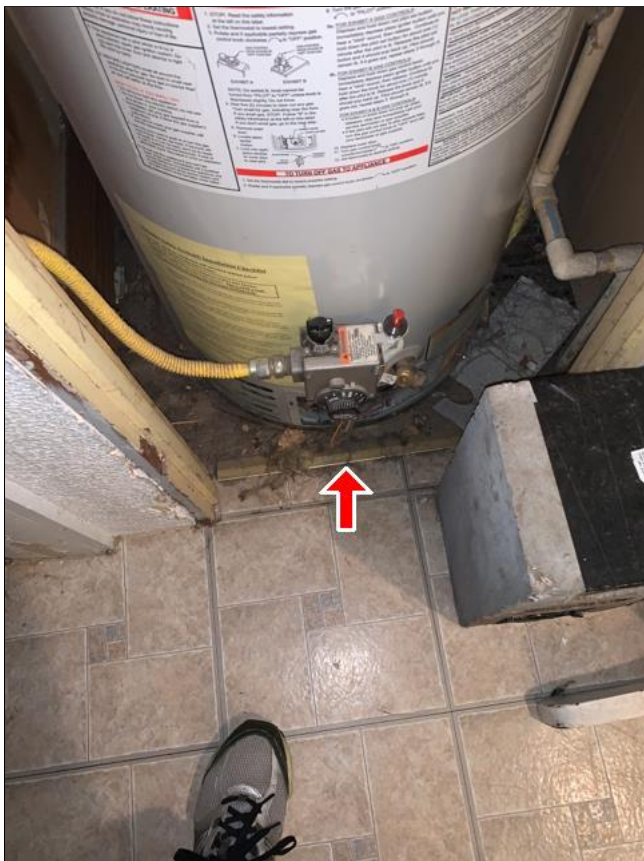
C. Item 2(Picture)

(3) Gas line has no sediment trap

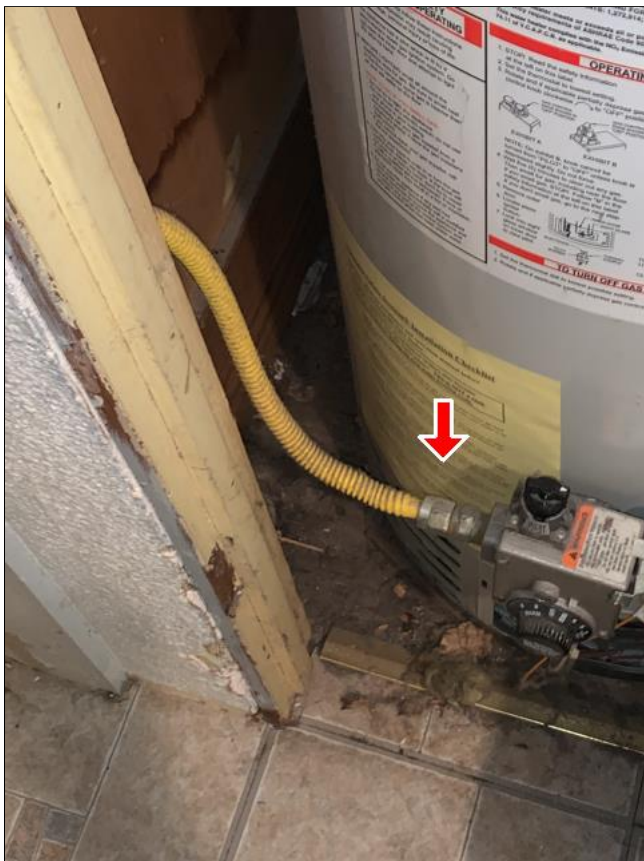
C. Item 3(Picture)

(4) Supply lines are leaking or corroded

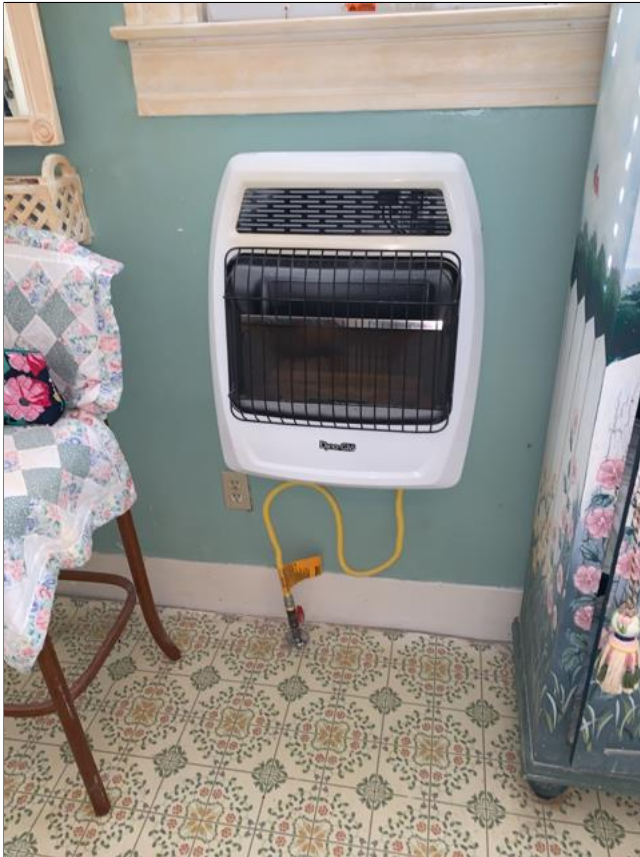
F. Item 1(Picture)

- (1) *Exhaust fans are operated and checked for proper function, vibration and vent pipe termination.*
- (2) Exhaust fans are not installed in the bathrooms
- (3) Unvented heating units are not considered to be safe. Carbon monoxide Exhaust directly into the home
