# Inspection Report

**Property Address:**  
Sample  
Houston TX 77008

# PROPERTY INSPECTION REPORT

**By:** TREC#'s 288, 21245, 21907 / ABET Home Services 10/10/2019

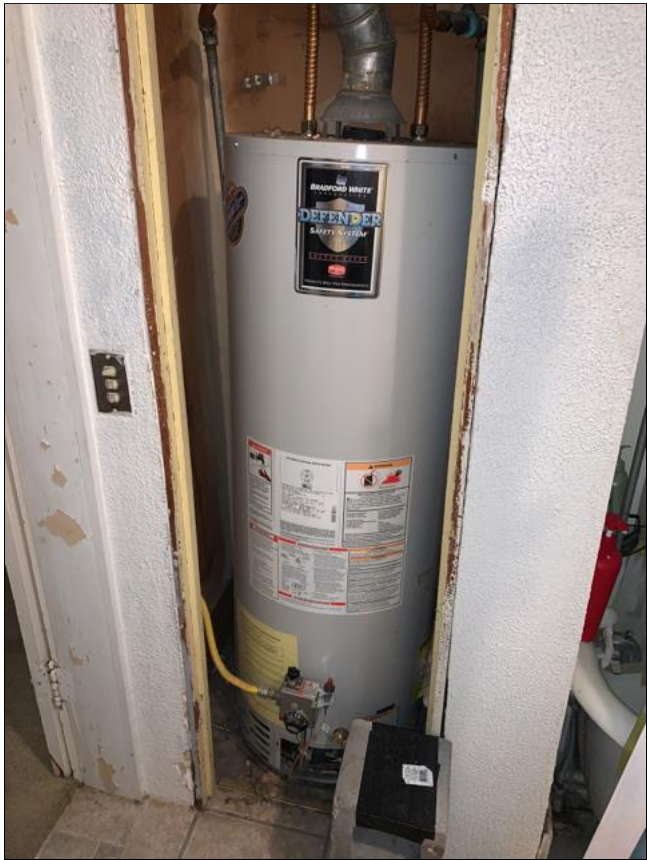
C. Item 1(Picture)

(1) *The location, capacity and energy source of water heaters is noted. Water heaters were inspected for general physical condition, obvious leakage, proper operation, appropriate locations and proper clearances. Units are also inspected for presence of drain pans and drain lines, presence of temperature and pressure relief valve, proper type of vent pipes and termination of vent pipes. Gas lines and Gas shut-off valves were also inspected.*

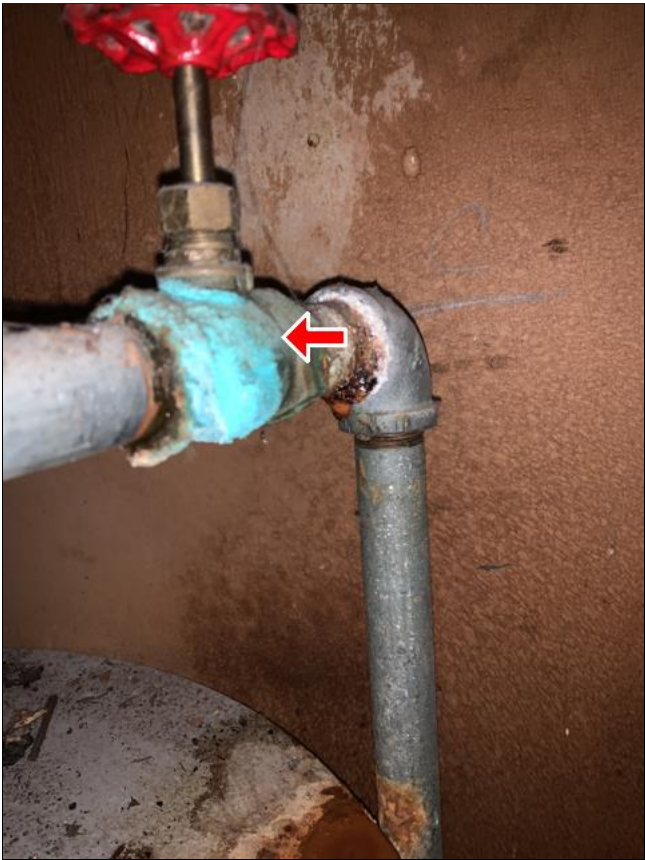
C. Item 4(Picture)

(4) Supply lines are leaking or corroded

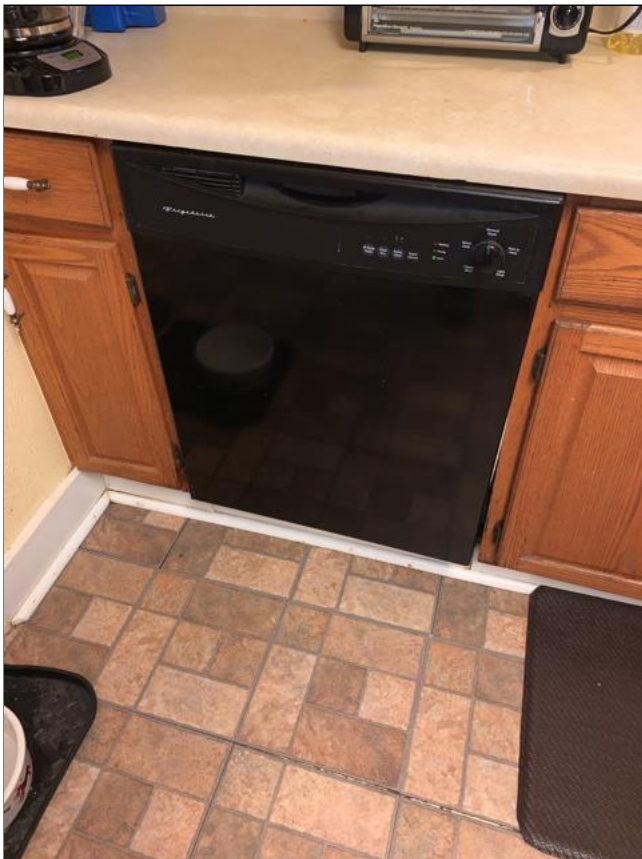
A. Item 1(Picture)

*Dishwasher was operated through a complete normal cycle during the time of inspection. The unit was inspected for deficiencies in mounting, performance and general condition. The presence of a back-flow prevention device is also inspected.*
